Public Works Committee

Tuesday, January 10, 2023

# Starin Park Water Tower Structural Analysis Report

**Project Address:** 504 W. Starin Road  
Whitewater, WI 53190

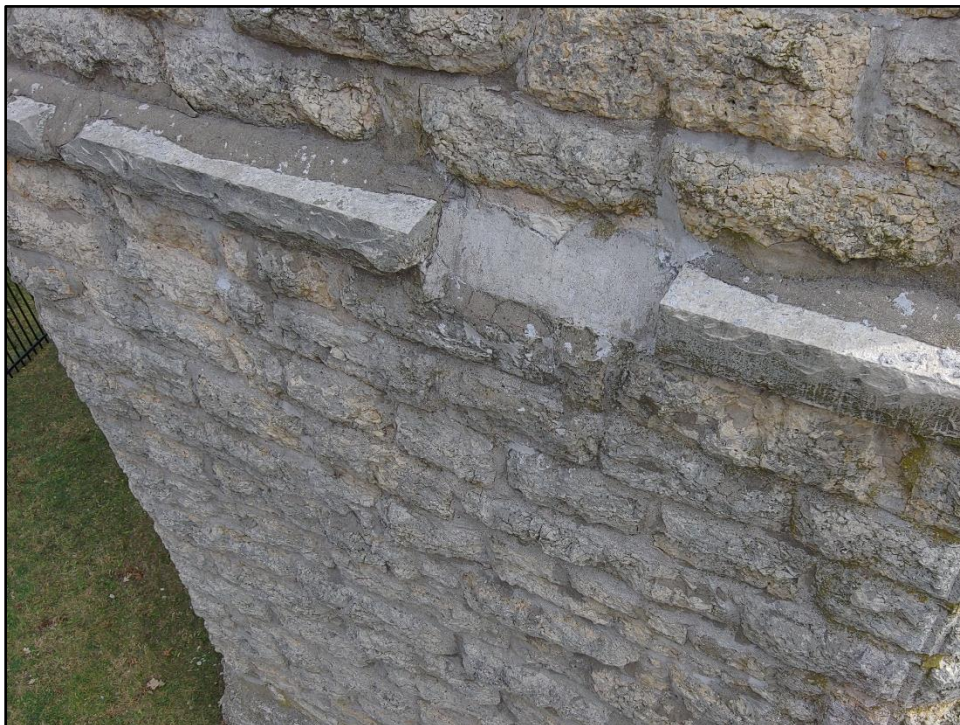
**Description:** Many of the stones at each belt course are in poor condition. There are stones that have fallen out or have been removed (Photo 12). Many stones that remain in place are cracked, spalled or delaminated (Photo 13 to 15).

These horizontal projections are natural places for water to enter the wall. This condition is likely due to decades of water and ice buildup along the ledges. There are mortar washes that have been installed to help shed water, but the deterioration has continued.

**Photo 12: Missing stone**

**Repair:** Replace stones that are missing as well as any that are severely deteriorated and have lots of cracking. For any stones that have minor cracking but are otherwise in generally good condition, consider pinning across the crack, or adhering the stone pieces with epoxy.

**Priority Level:** High

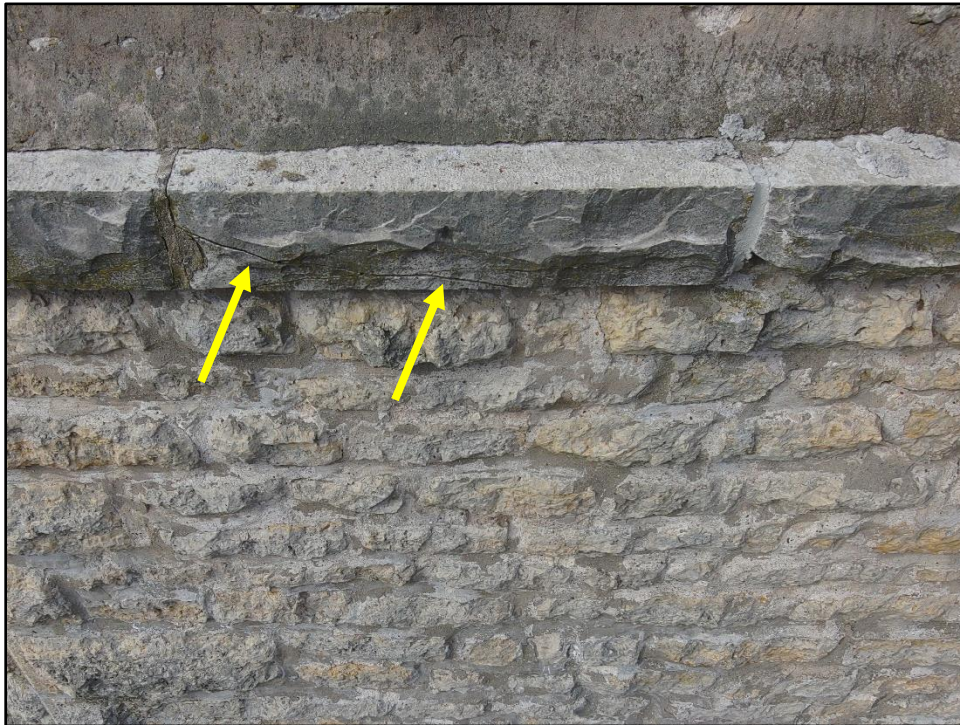
**Photo 13: Horizontal cracks in stone**

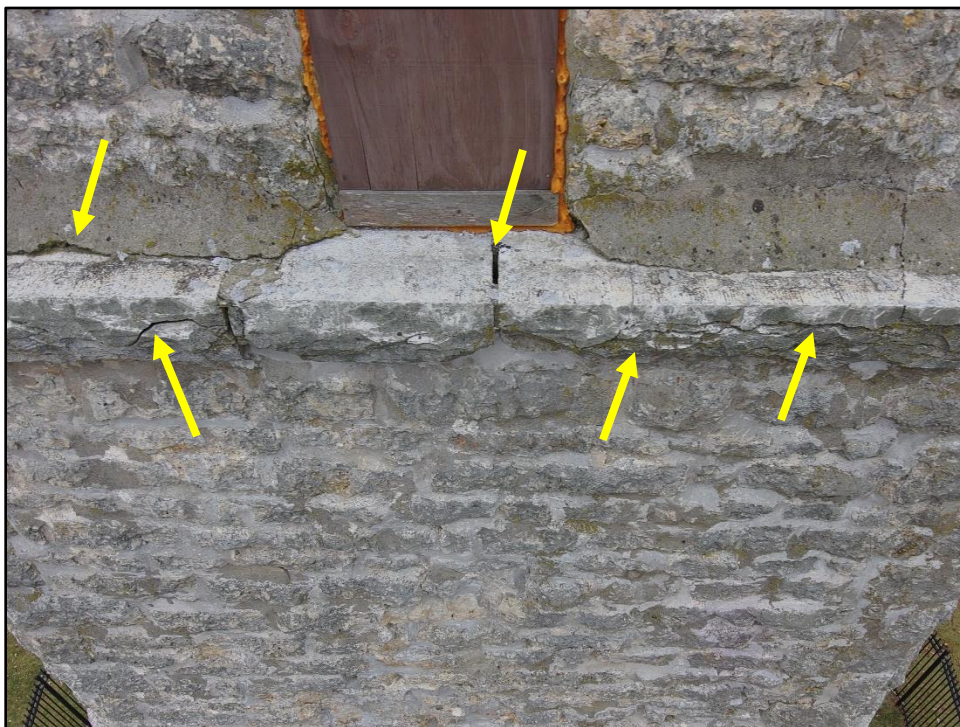
**Photo 14: Cracked stones, missing mortar, deteriorating mortar wash**

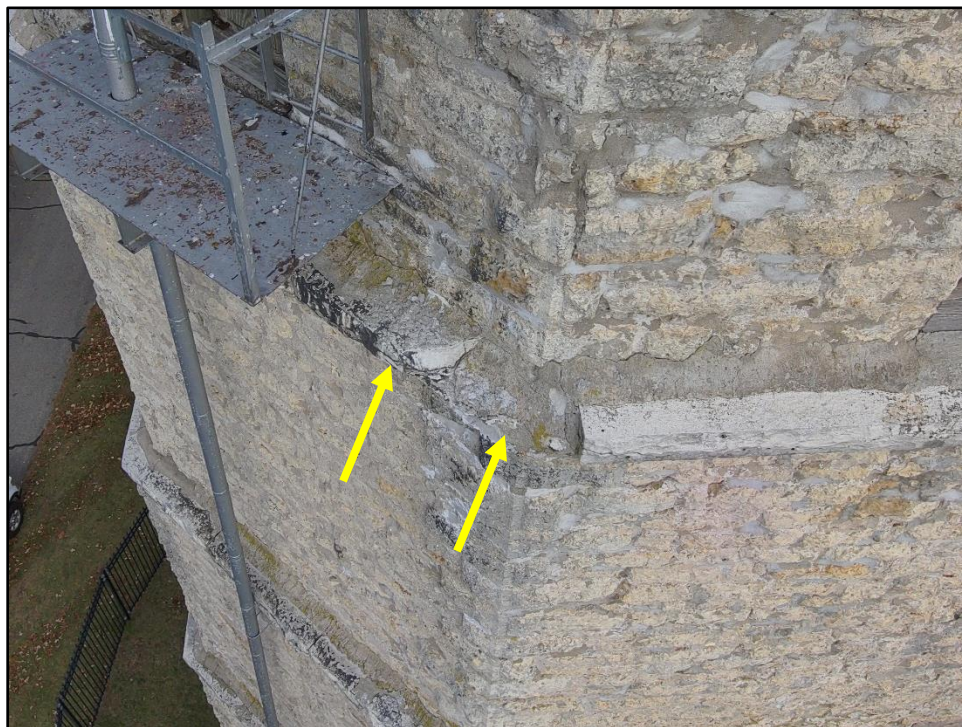
**Photo 15: Missing stone, cracked stone, deteriorating mortar wash**

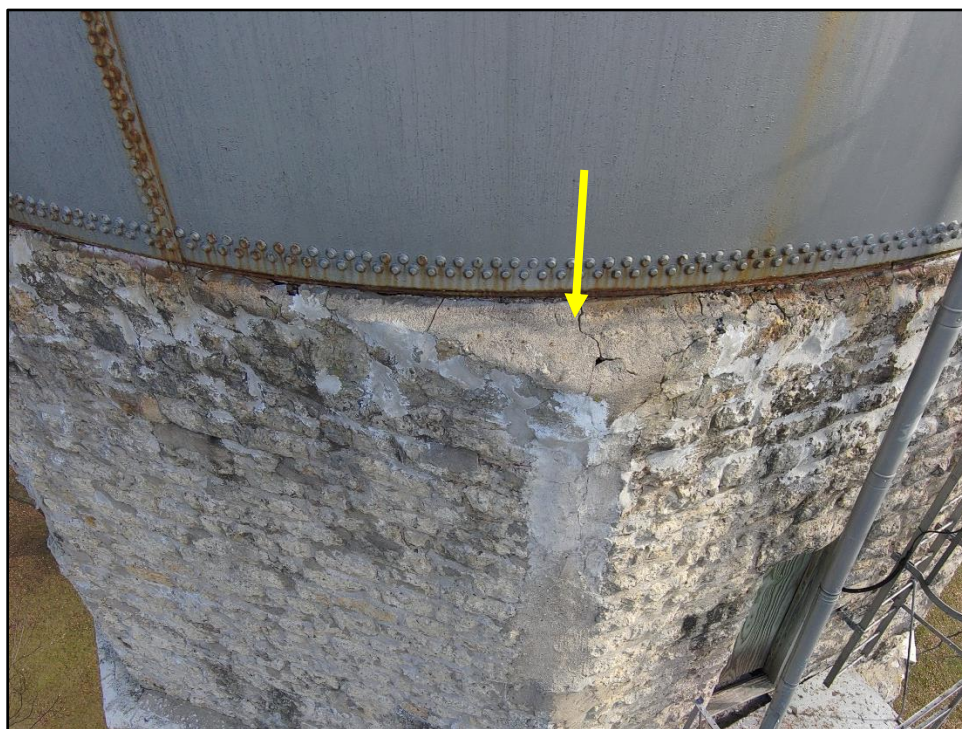
This condition is particularly bad at the top of the wall (Photos 16 and 17). There is more exposed masonry here that can take on water. Also, the embedded steel tank supports are corroding and likely causing additional damage to the masonry. See Condition #7 for more discussion of the steel corrosion.

**Photo 16: Deteriorating mortar wash at top of wall**

Consider adding a coping or flashing at the horizontal surfaces, particularly at the top of the wall. Keeping water out of the wall in the future will be critical to maintaining this structure. This approach comes with downsides as well though as creating a system that would be effective and also not change the appearance of the structure would be challenging. This is an architectural issue to consider during the design of repairs.

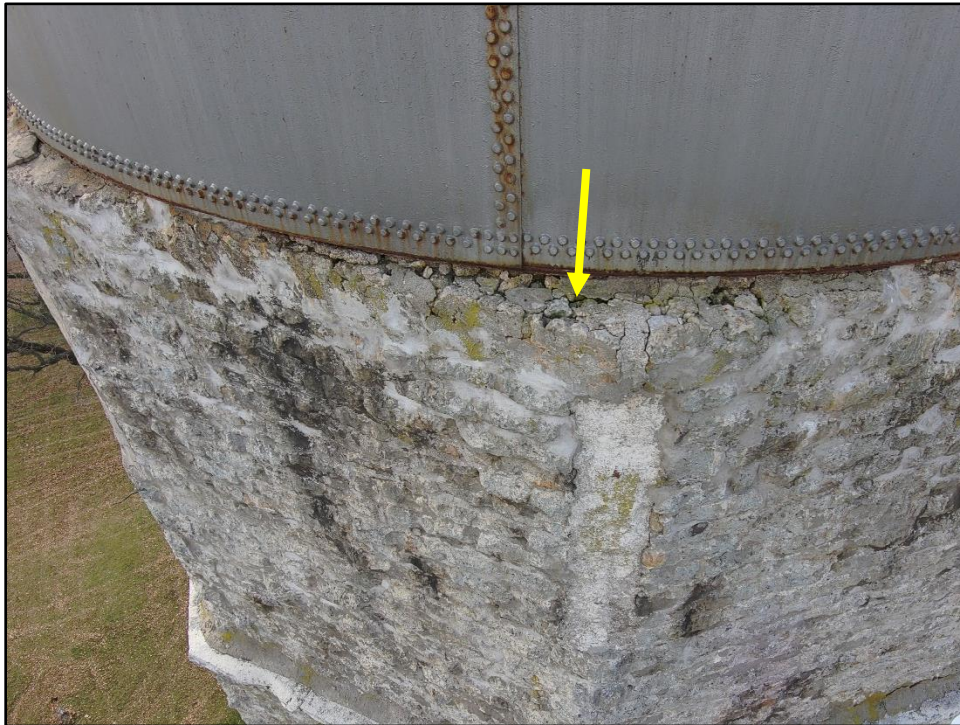
**Photo 17: Deteriorating masonry at top of wall**

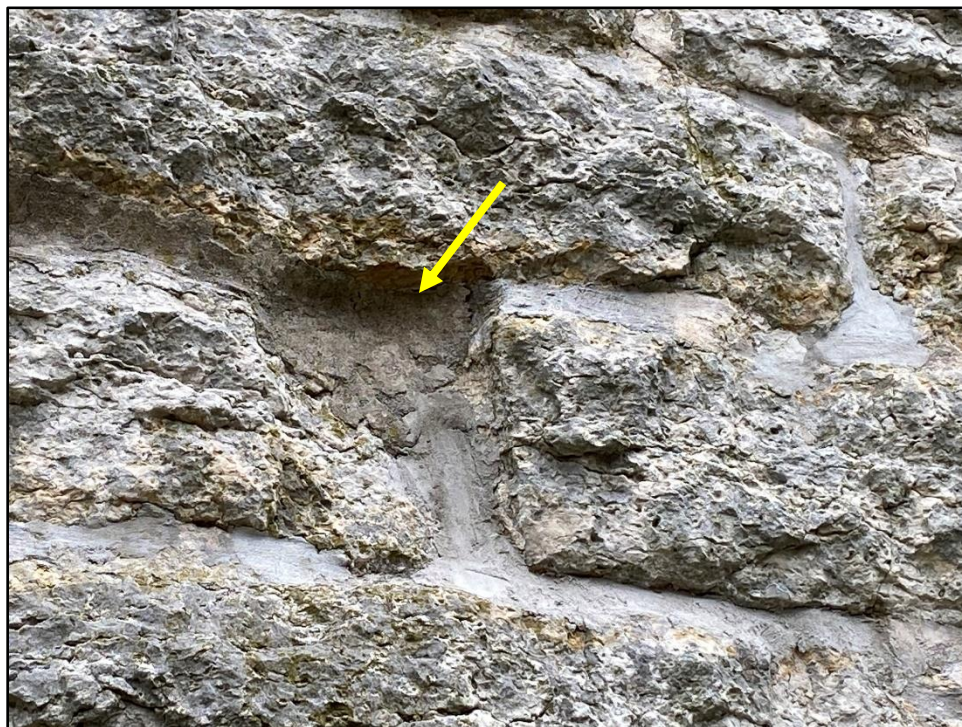
**Description:** There are some isolated locations where stone has spalled and broken away from the structure (Photo 18). The sides of the wall openings have some spalling (Photo 19). Only one location was easily visible during this assessment, but we would expect to find conditions like this at other openings as well. One area at the top tier has a larger area that has spalled away (Photo 20). There is also some deterioration of stone near the base of the wall (Photo 21).

**Photo 18: Isolated locations of stone spalls**

**Repair:** Areas with isolated spalled stones do not need to be repaired at this time. If a full restoration of the building is undertaken, it may be decided whether or not these locations should be addressed.

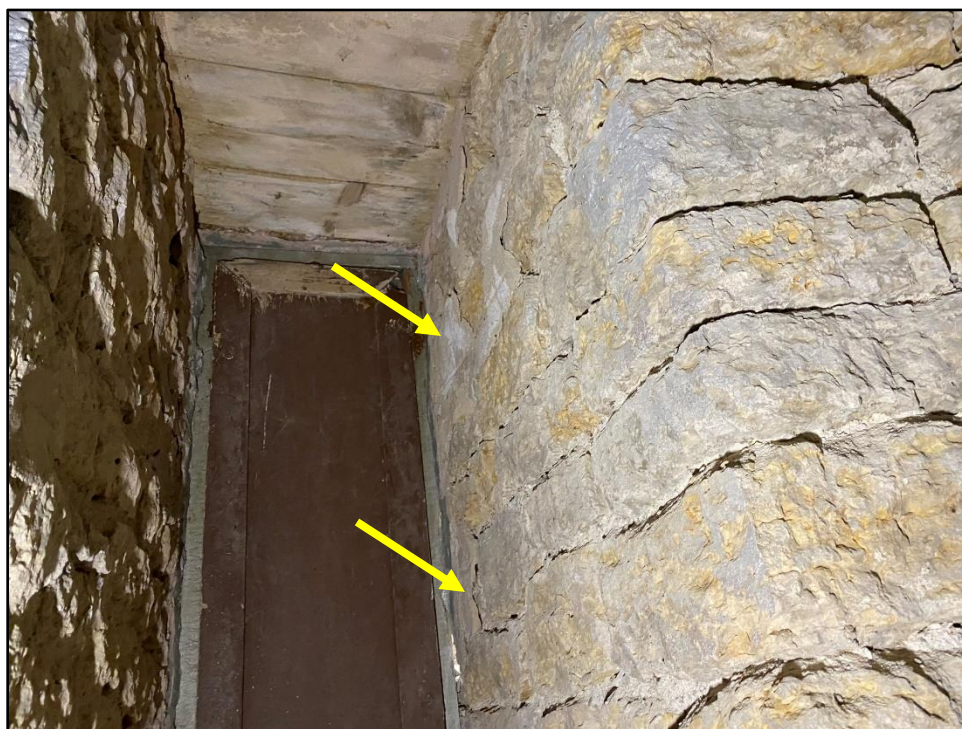
**Photo 19: Spalled stone on “door” walls**

The sides of the wall openings could be address on a case by case basis when access is available to those areas. The one area visible during this investigation did not appear to be in dire condition and can wait until a repair plan is executed

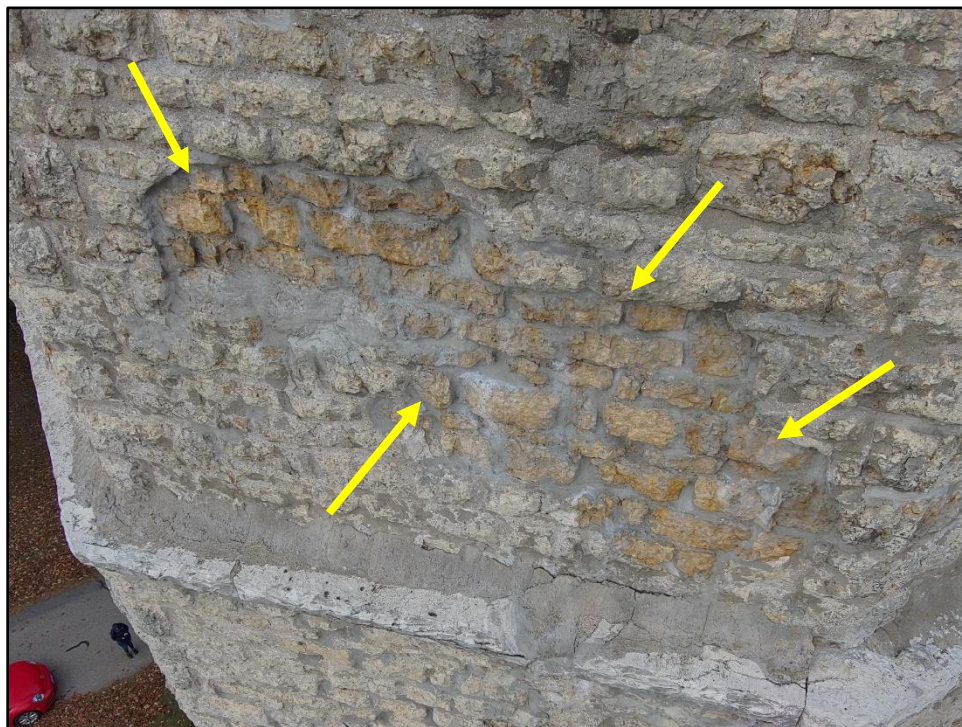
**Photo 20: Area of spalled stone – top tier, southeast elevation**

The large spall area shown in Photo 20 should be investigated up close in more detail. There is a possibility that the stones around this area are unstable and would require remediation. If the stone is loose at all, it could be pinned into place. Alternately, the missing/spalled stones could be replaced/repared which would stabilize this area of the wall.

**Priority Level:** High – Pinning area around large spall

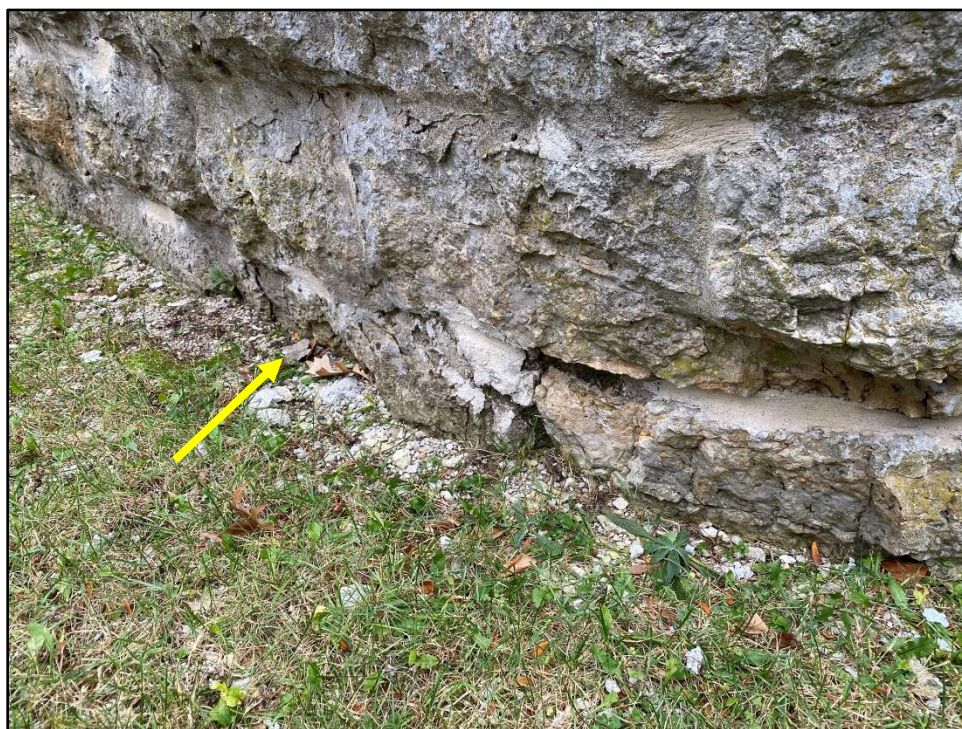
**Photo 21: Stone deterioration at base of wall**

Deterioration at the base of the wall can be address during a full repair as well. It is not so significant as to require repairs at this time. This is an easily monitored condition due to the location on the building.

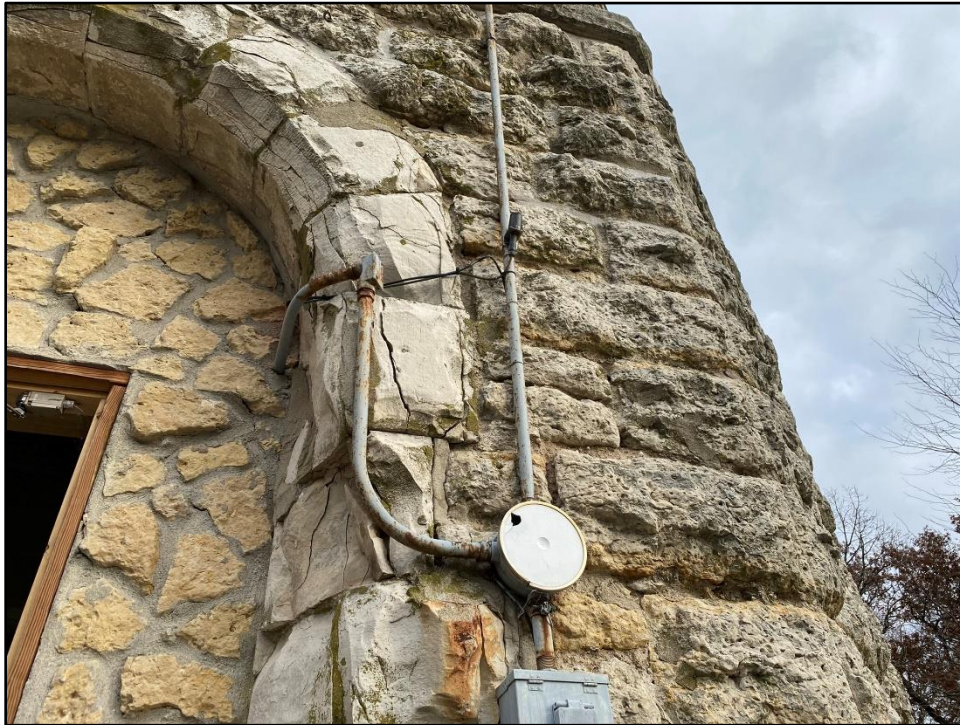
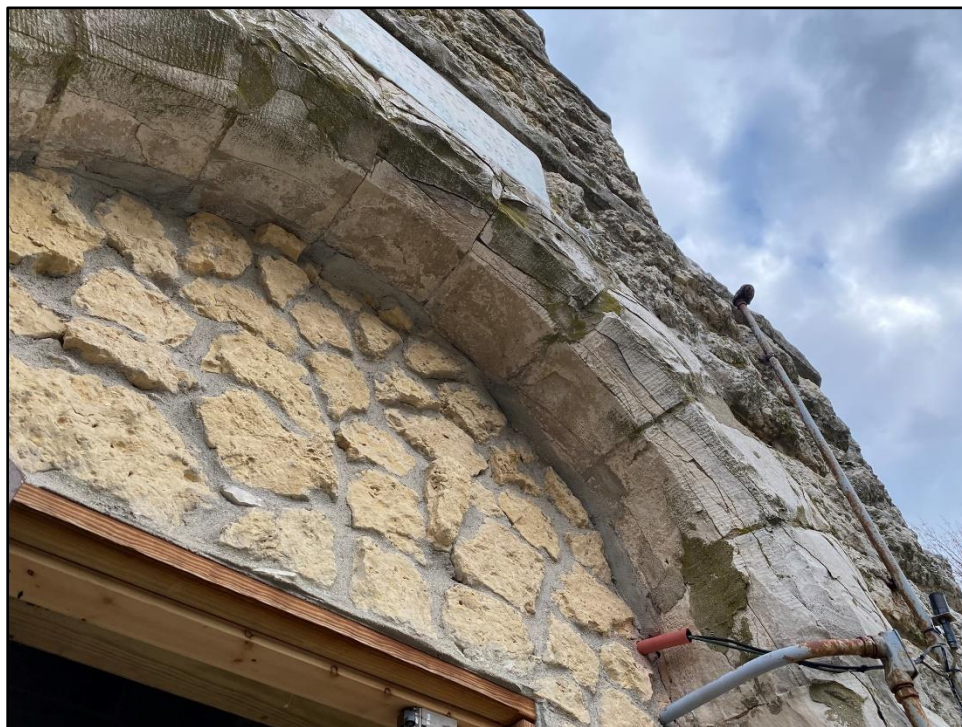
**Description:** Stones in some locations have significant cracking. This is particularly prevalent in the arched stones at the entryway (Photos 22 and 23). Also see Condition #1 for cracking in stones at the belt courses.

**Photo 22: Cracked stone in entryway arch**

**Photo 23: Cracked stone in entryway arch**

**Repair:** For a long-term repair, these stones should be replaced. The cracking is too extensive for an in-place repair to be effective.

**Priority Level:** High

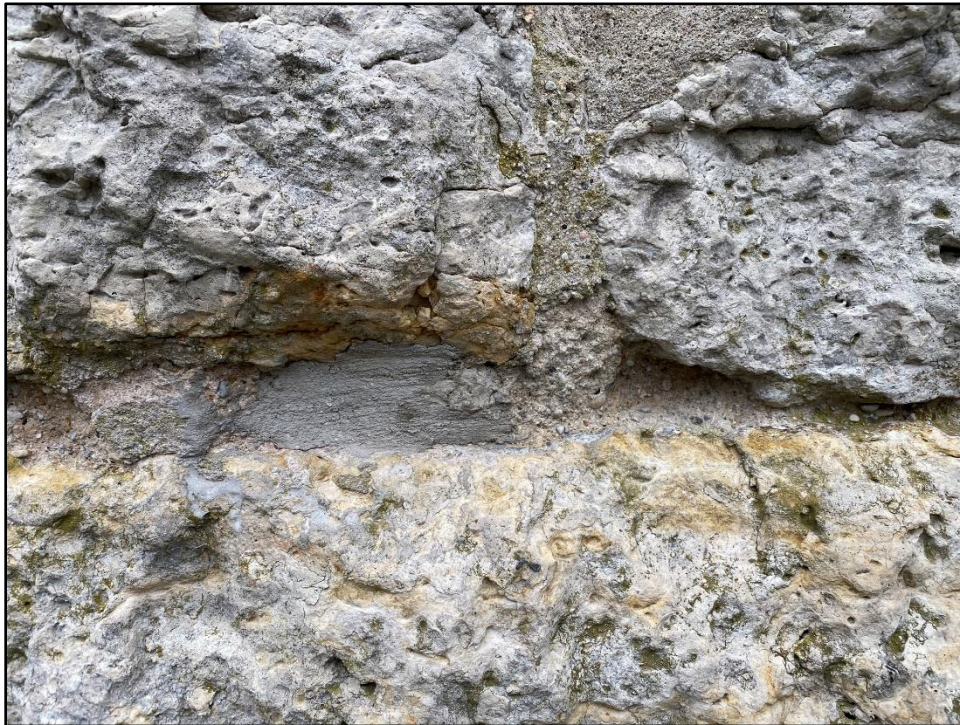
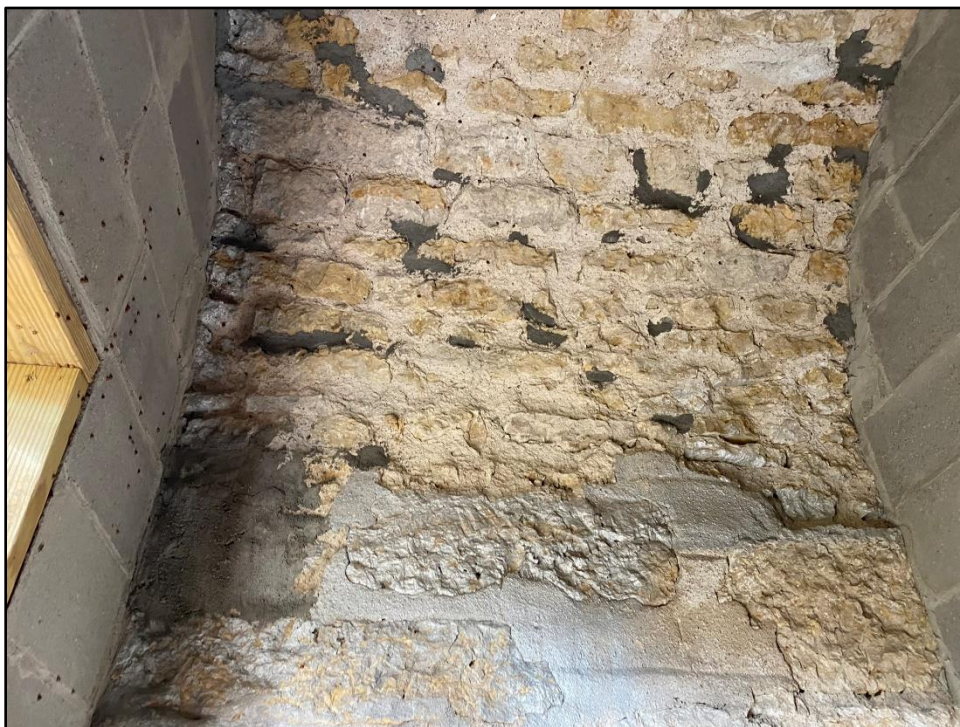
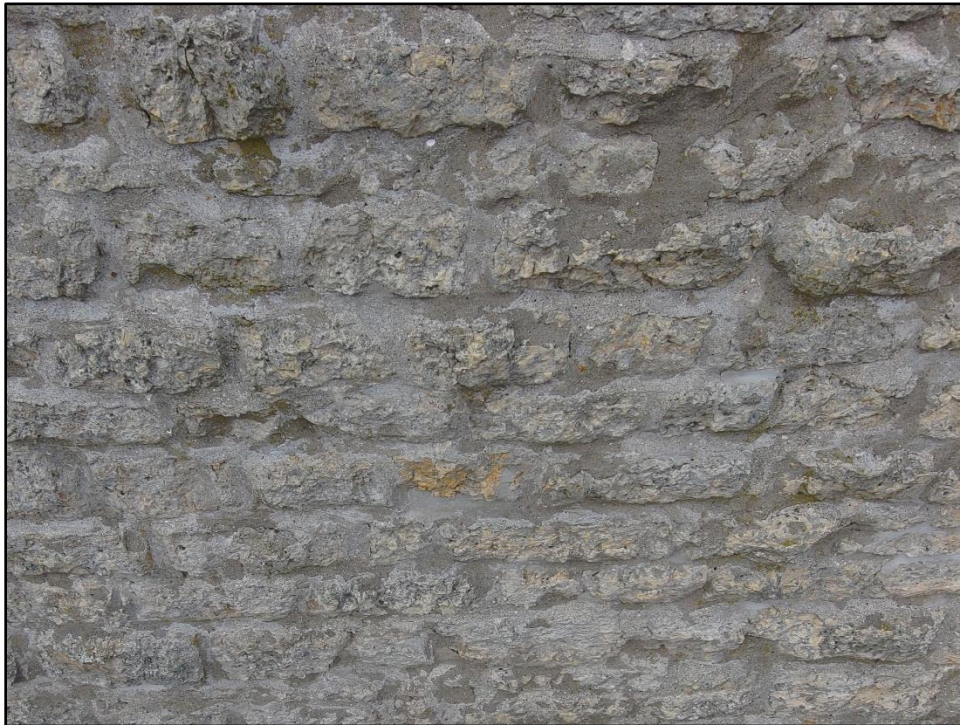
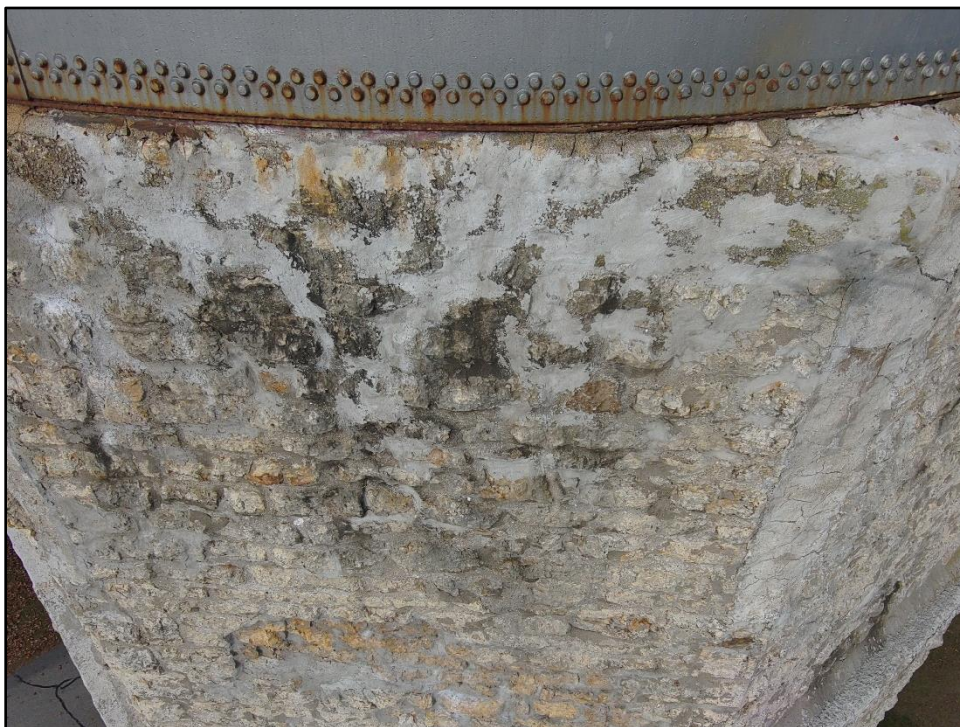
The exterior wall joints have had a lot of spot repointing in the past (Photos 24 to 27), which is to be expected for most structures. It does appear that some of the previous mortar may be harder than appropriate, which may be the cause of some of the isolated stone spalling and cracking.

**Photo 24: Different types of mortar**

**Photo 25: Different mortar at entry arch**

**Photo 26: Repointed joints at mid-height of tower**

**Photo 27: Repointing mortar at top of tower**

**Repair:** Repoint loose mortar joints. The joints on the exterior should have a higher priority than those on the interior. Repointing can be performed in sections throughout the building over time, or when access is available. For the purpose of planning, it would be appropriate to assume that 5% to 10% of the building will need to be repointed. While most of the building is in good condition at this time, the joints will continue to deteriorate while planning progresses and if repairs are staged over time.

The mortar should be matched to the original mortar. Prior to performing any repair work on this building, the mortar should be analyzed to determine the composition of the appropriate repair mortar.

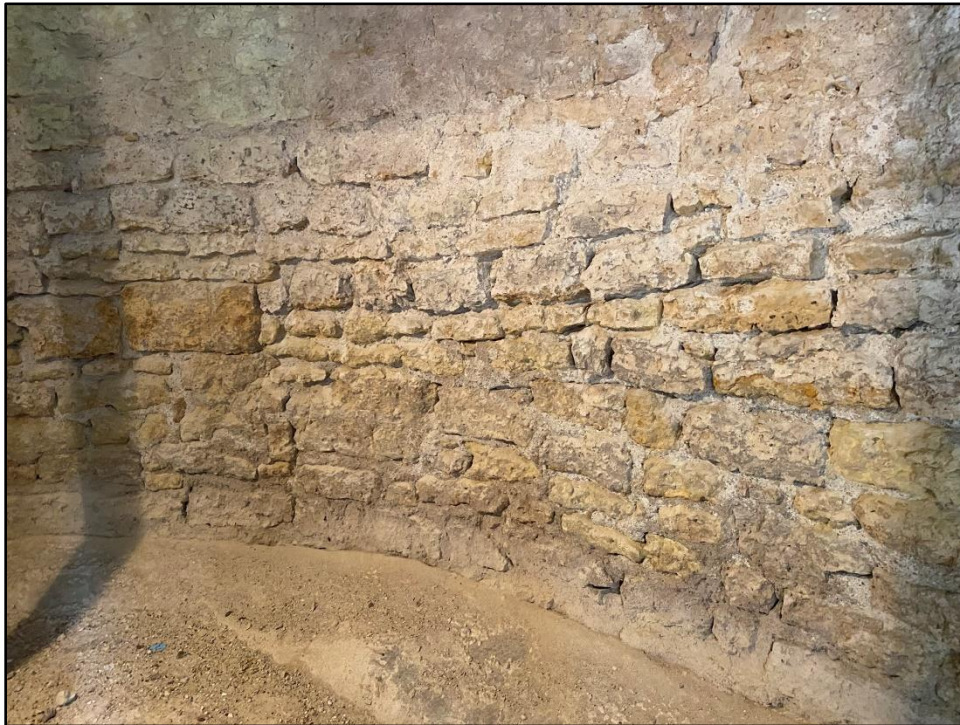
The interior wall joints are very loose and mortar is falling out of the joints and collecting on the floor (Photo 28).

Keeping mortar joints in good condition is key to the longevity of this structure. Given the age of the structure, we would anticipate that the original lime mortar used would be deteriorating and reverting to a sandy material. This is not necessarily an issue near the center of the wall as long as it is kept in place by the mortar on the wall faces.

**Photo 28: Deteriorated joints on interior – dust on floor is deteriorated mortar**

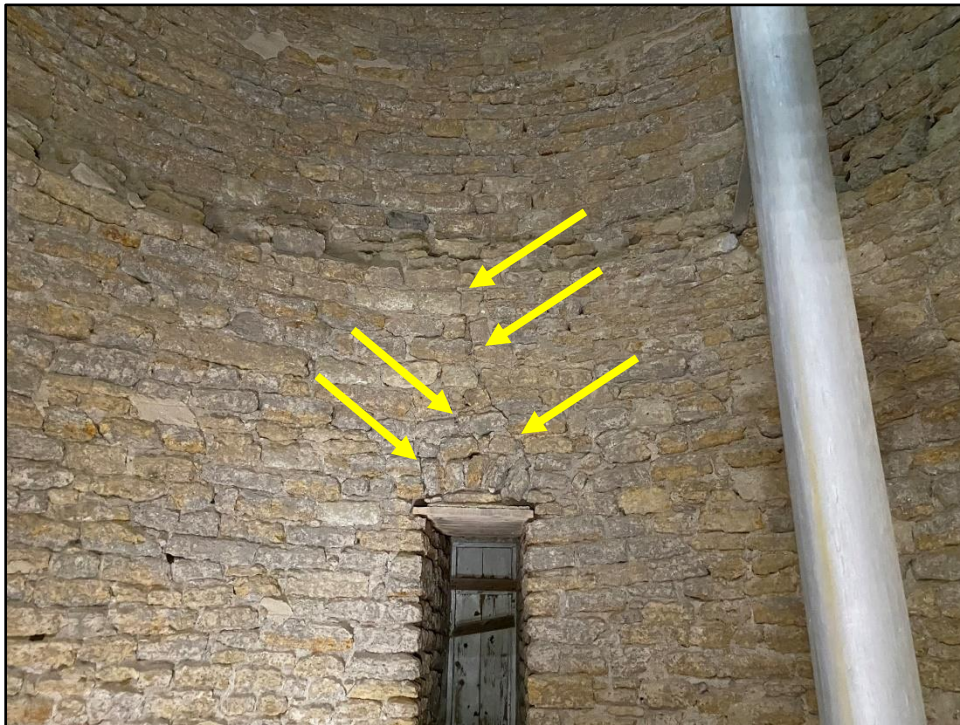
- Description:** A crack was noted on the interior of the structure above an opening on the north wall (Photo 29).
- Repair:** Repoint cracked mortar joints and epoxy or pin across cracks in the stone.
- Priority Level:** Monitor until interior repointing is performed, or unless additional movement occurs.

**Photo 29: Crack on interior of tower**

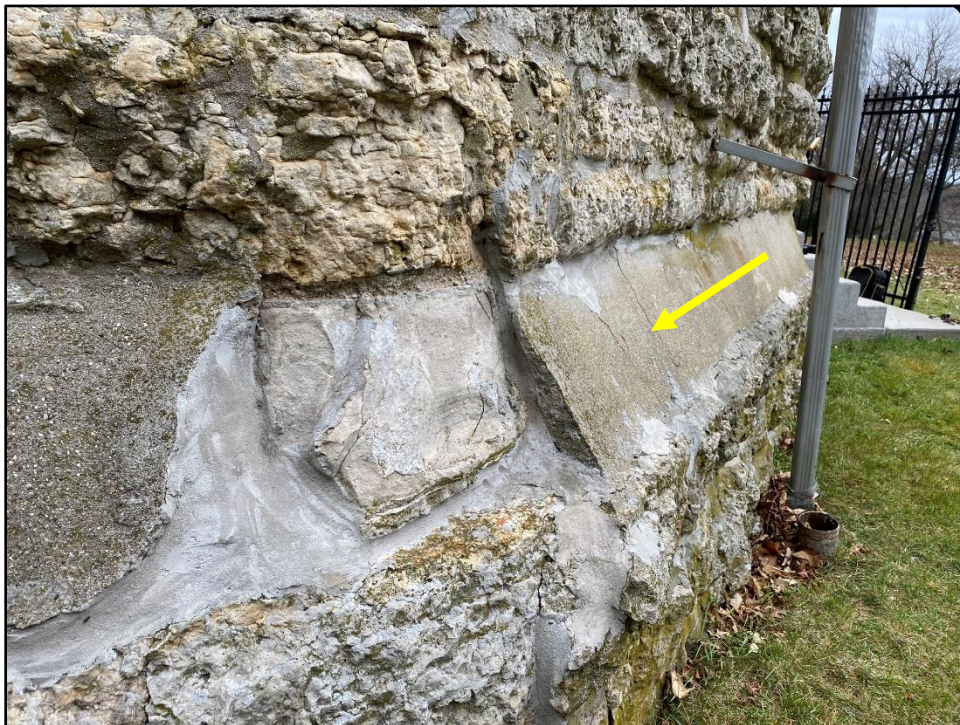
**Description:** There has been a concrete or mortar wash placed at the base of the wall. It has fallen off in many locations and is cracked in other locations (Photo 30). The use of concrete or a hard mortar is not appropriate for this building.

**Photo 30: Cracked and missing concrete/mortar wash**

**Repair:** When belt courses discussed in Condition #1 are being addressed, repair this as well. There may need to be stones replaced where they are cracked or spalled. Mortar joints should be replaced. If there is still a need for water deflection at this location, consider installing a mortar wash with a material matching the original building mortar, but anticipate that it will need to be maintained on a regular basis.

**Priority Level:** High – coordinate repairs with belt course repairs.

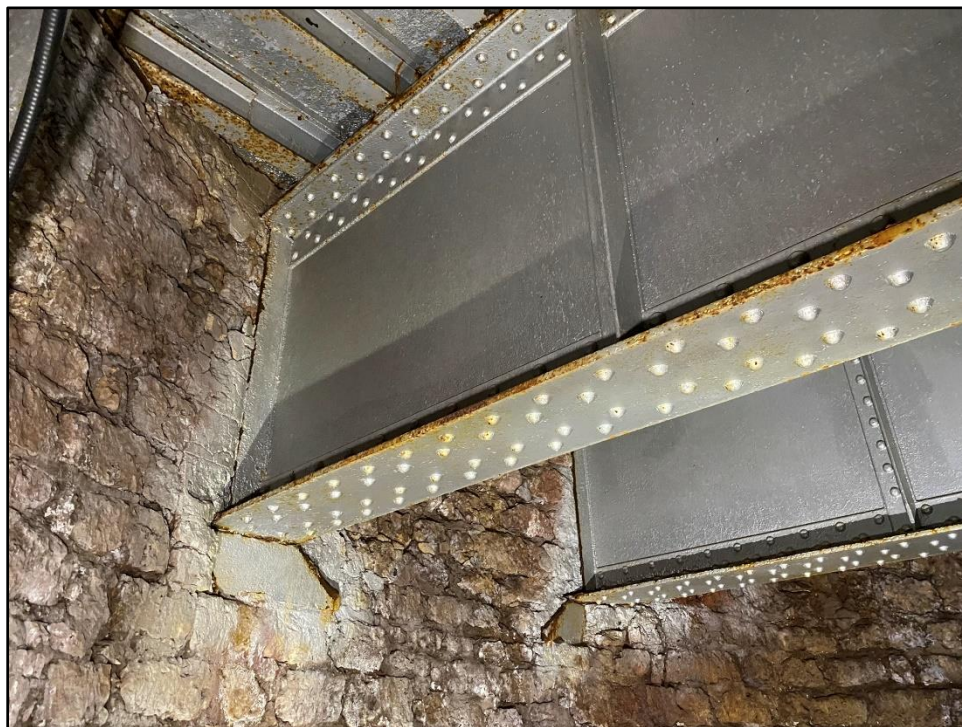
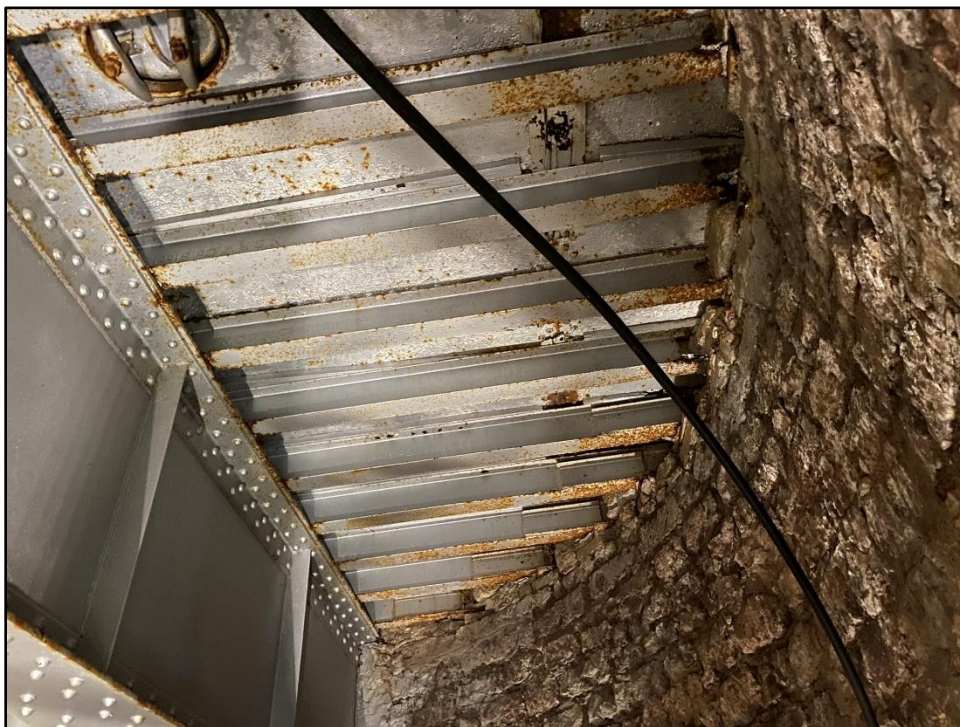
- Description:** The steel beams and plate girders holding the tank have light corrosion, particularly near the masonry walls (Photos 31 to 33). The beams that form the floor below the tank also have corrosion at the exterior walls (Photos 34 and 35).

**Photo 31: General light corrosion on support structure**

**Photo 33: General surface corrosion of tank support beams with an increase near walls**

- Repair:** Perform some exploratory openings at locations where beams are bearing on walls. Exposing the steel members will determine whether repairs are needed. If repairs are needed it will likely involve welding new steel plates/angles/etc to the existing steel to replace the lost steel capacity.

- At a minimum, exposed steel members should be primed and painted to extend the life of the structure.
- Once water is removed from the tank, the interior should be inspected by a tank inspector to determine whether the tank itself, or its connections to the base, require repairs.

- Priority Level:** High – beams and girders that are bearing on masonry. These are a higher priority because their condition will impact the longevity of any masonry repairs.

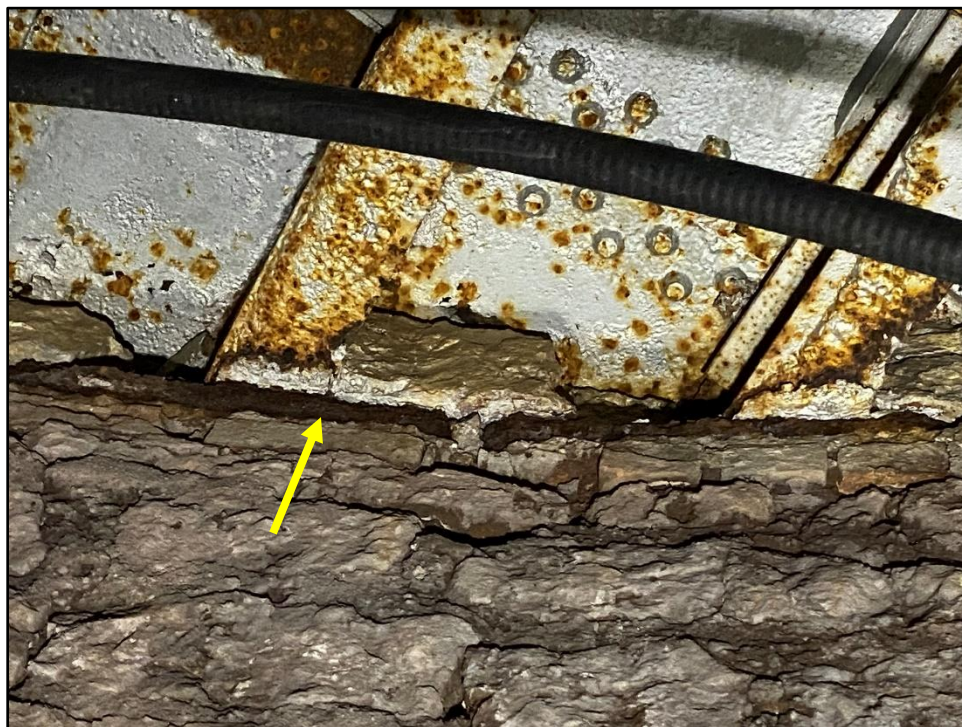
**Photo 32: Close up of tank supports at wall**

There is a steel plate on top of the masonry that is corroding as well as the base of the tank

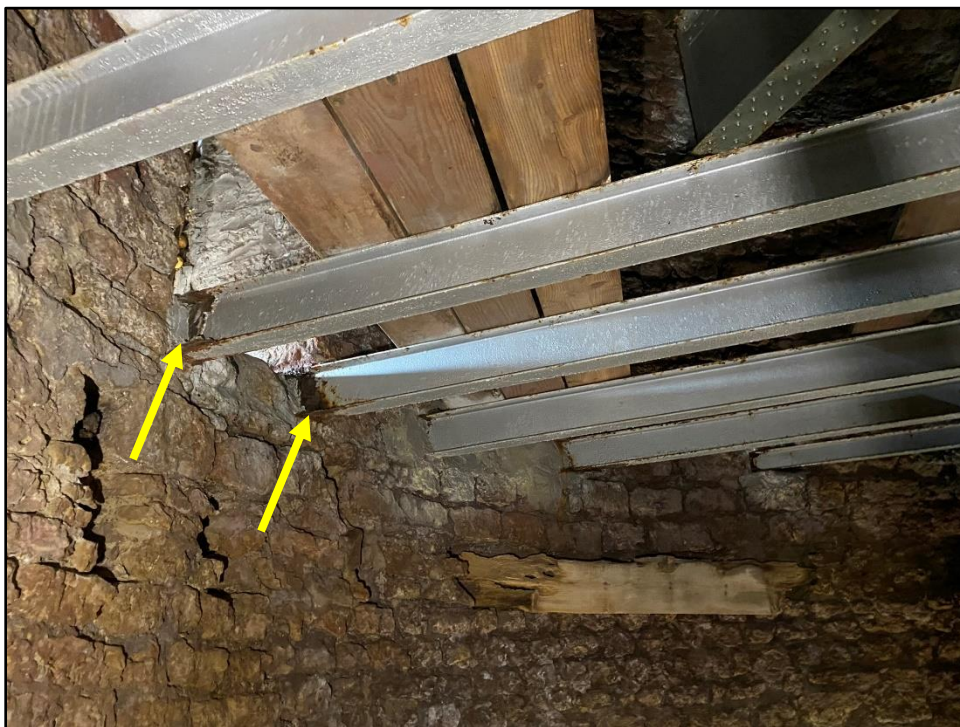
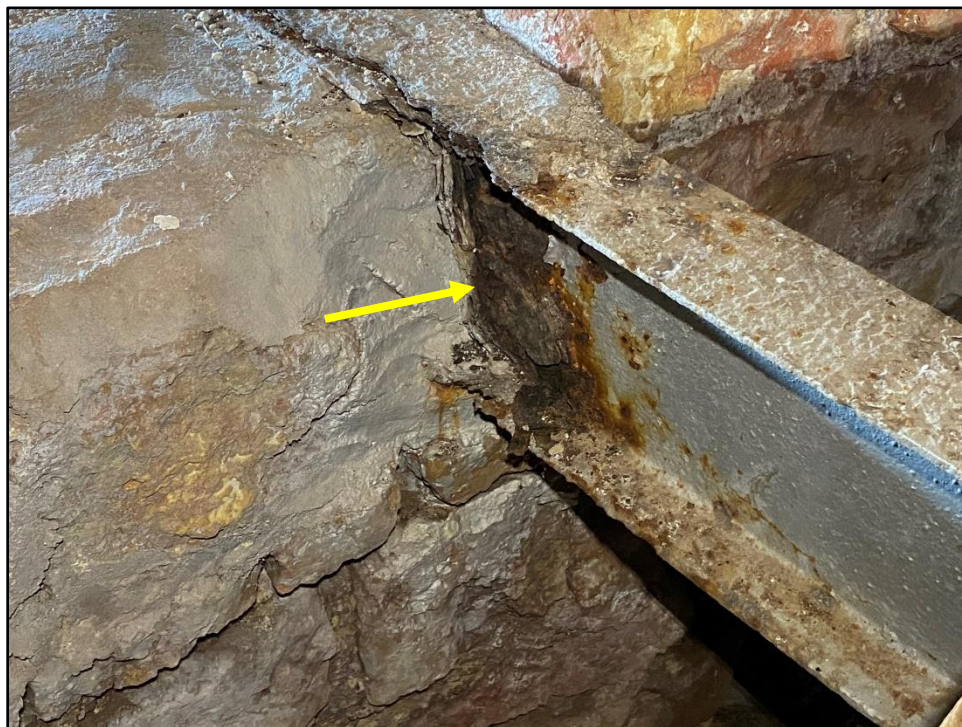
**Photo 34: Signs of floor beam corrosion at walls**

**Photo 35: Corroding floor beam at exit to exterior platform**

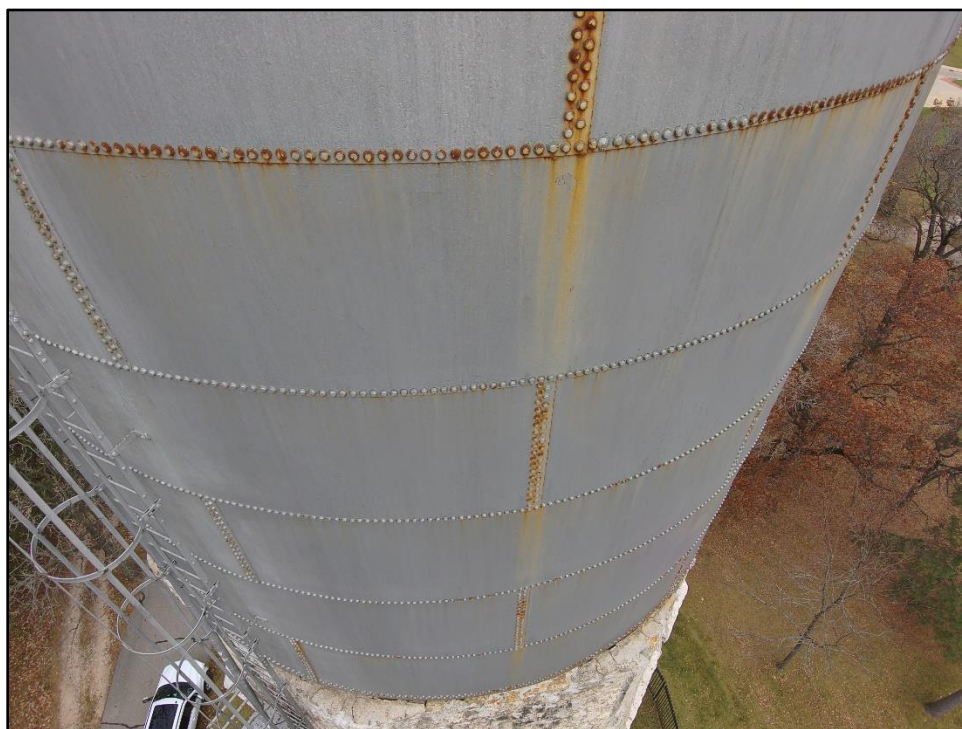
- The tank has some signs of corrosion on the exterior at the joints (Photo 36).
- The ladder on the interior of the structure has corrosion at the base and at some of the wall connections (Photos 37 and 38)

**Photo 36: Rust staining on exterior of tank**

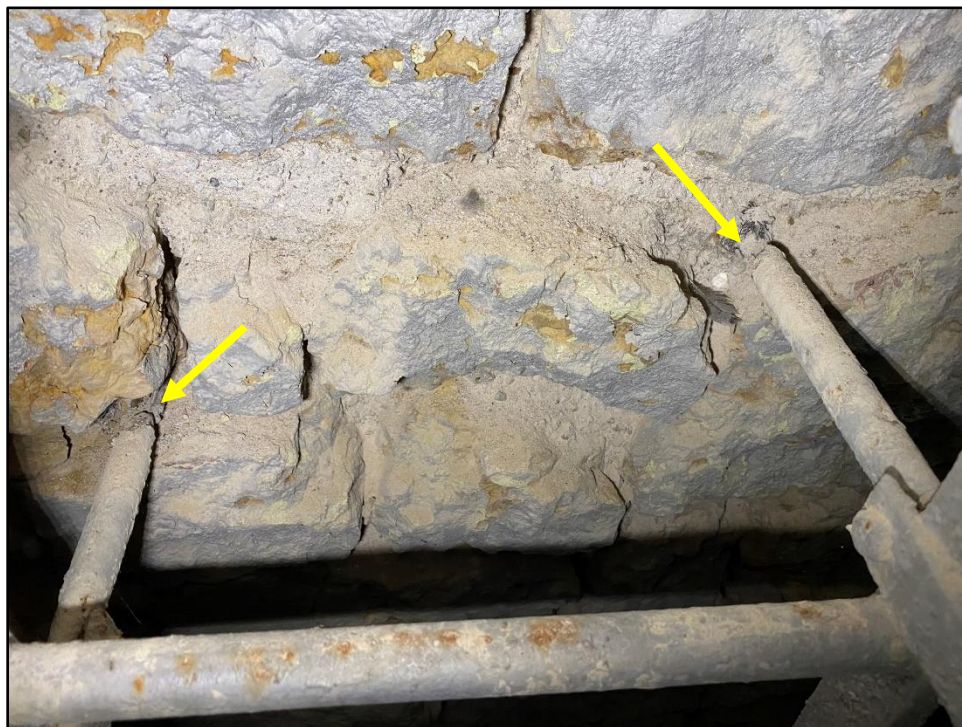
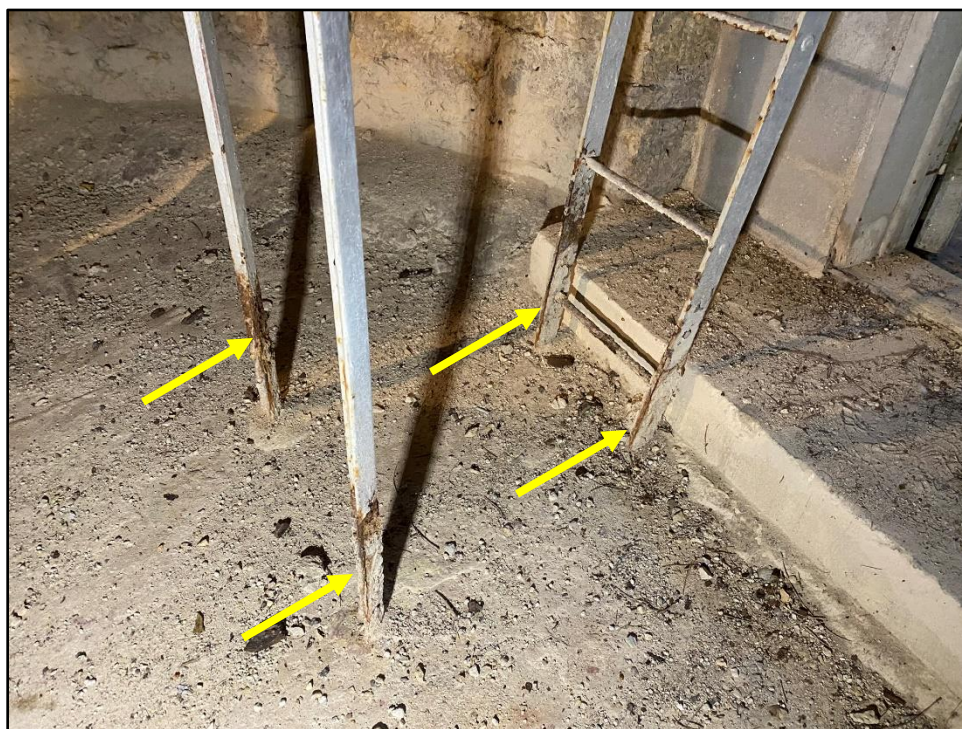
**Photo 37: Corroded ladder connections at wall**

**Photo 38: Base of interior ladder – corrosion on all pieces**

- High – Ladders or other access points
- Medium – All other locations

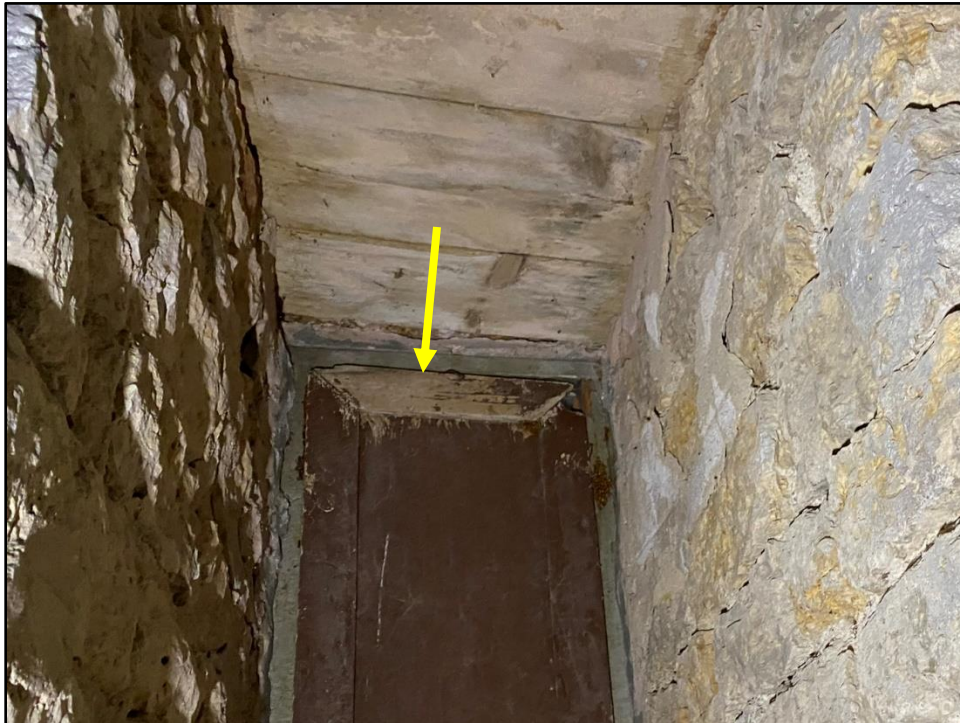
**Photo 39: Minor wood deterioration at access panels**

**Repair:** Replace deteriorating wood in kind.

**Priority Level:** Low/Monitor
