Wastewater Facility Update

December 1, 2016

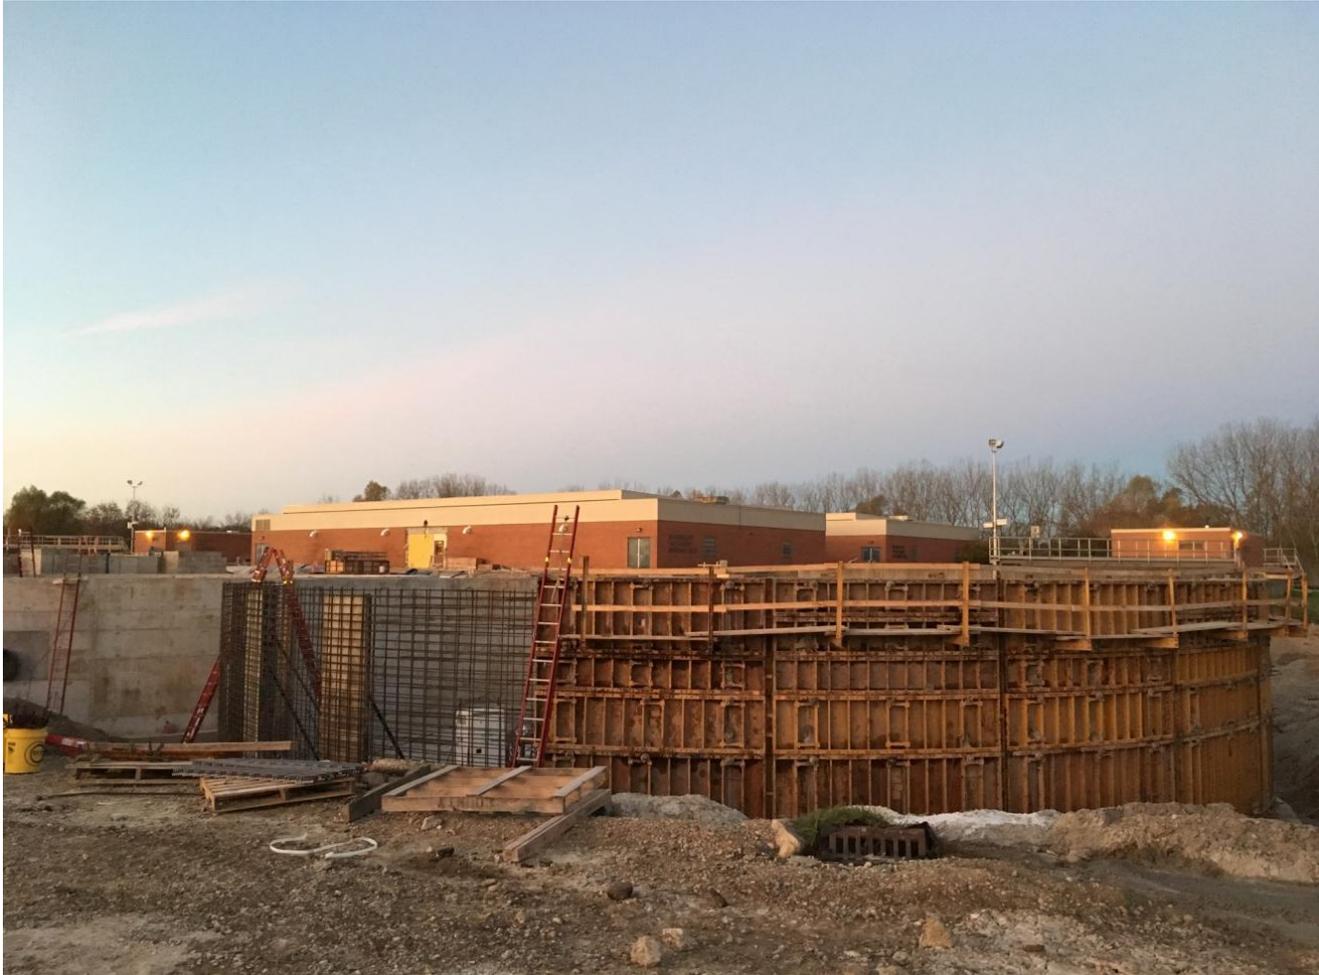
Secondary Clarifiers – 11/9/2016

Forming and pouring of the secondary clarifiers took place one quarter at a time.

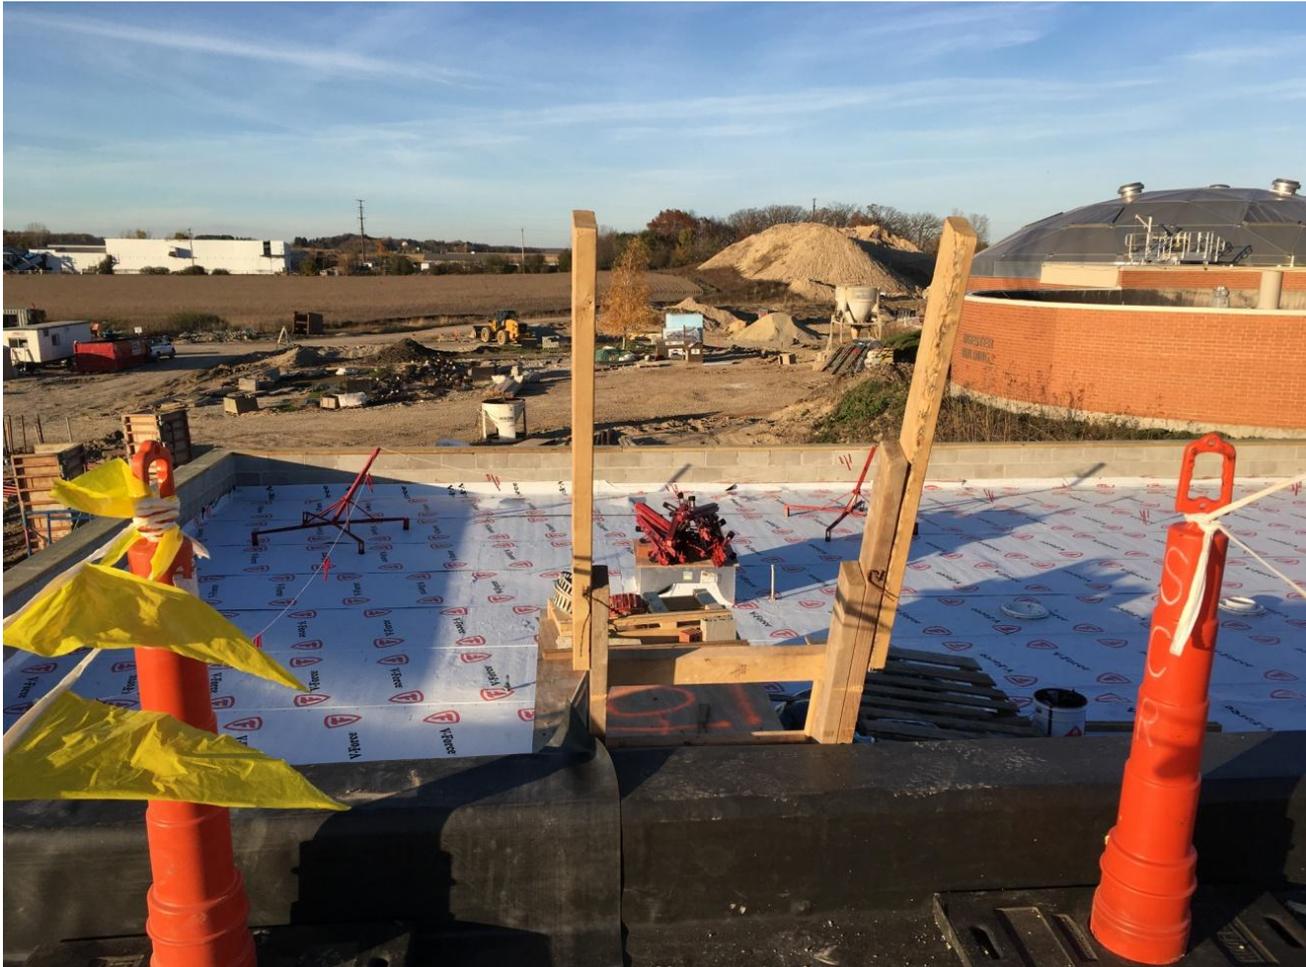
Process Bldg. – 11/9/2016

The roofing contractor was onsite from 11/7 – 11/11/16 to button up three roof sections in preparation for winter weather.

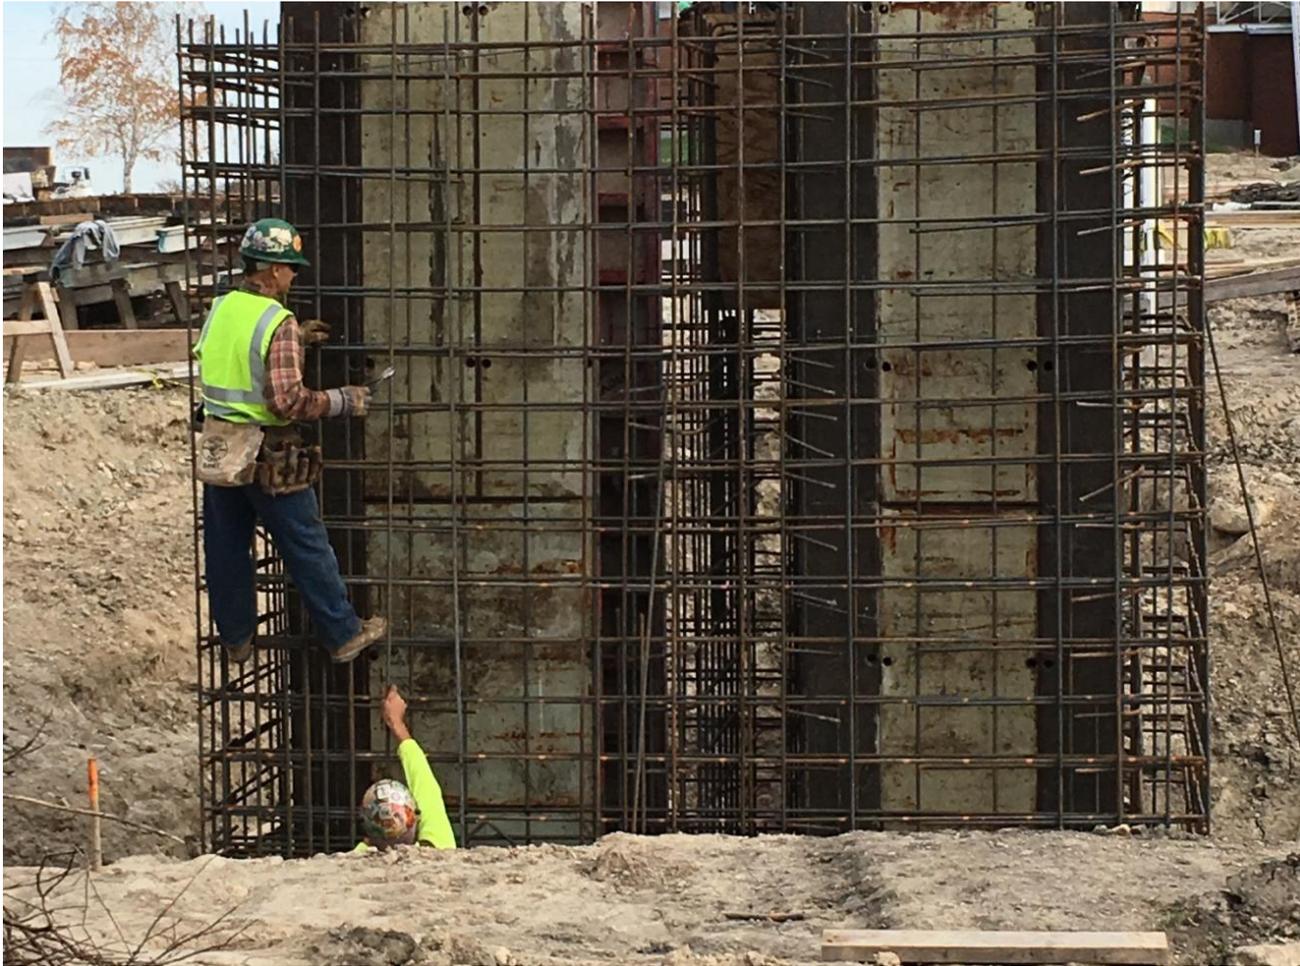
Filter Bypass Splitter – 11/9/16

Ironworkers from Chilstrom are busy tying rebar in preparation for pouring the walls. This structure will allow for the diversion of flow away from the filter cells if flow rates exceed filter capacity.

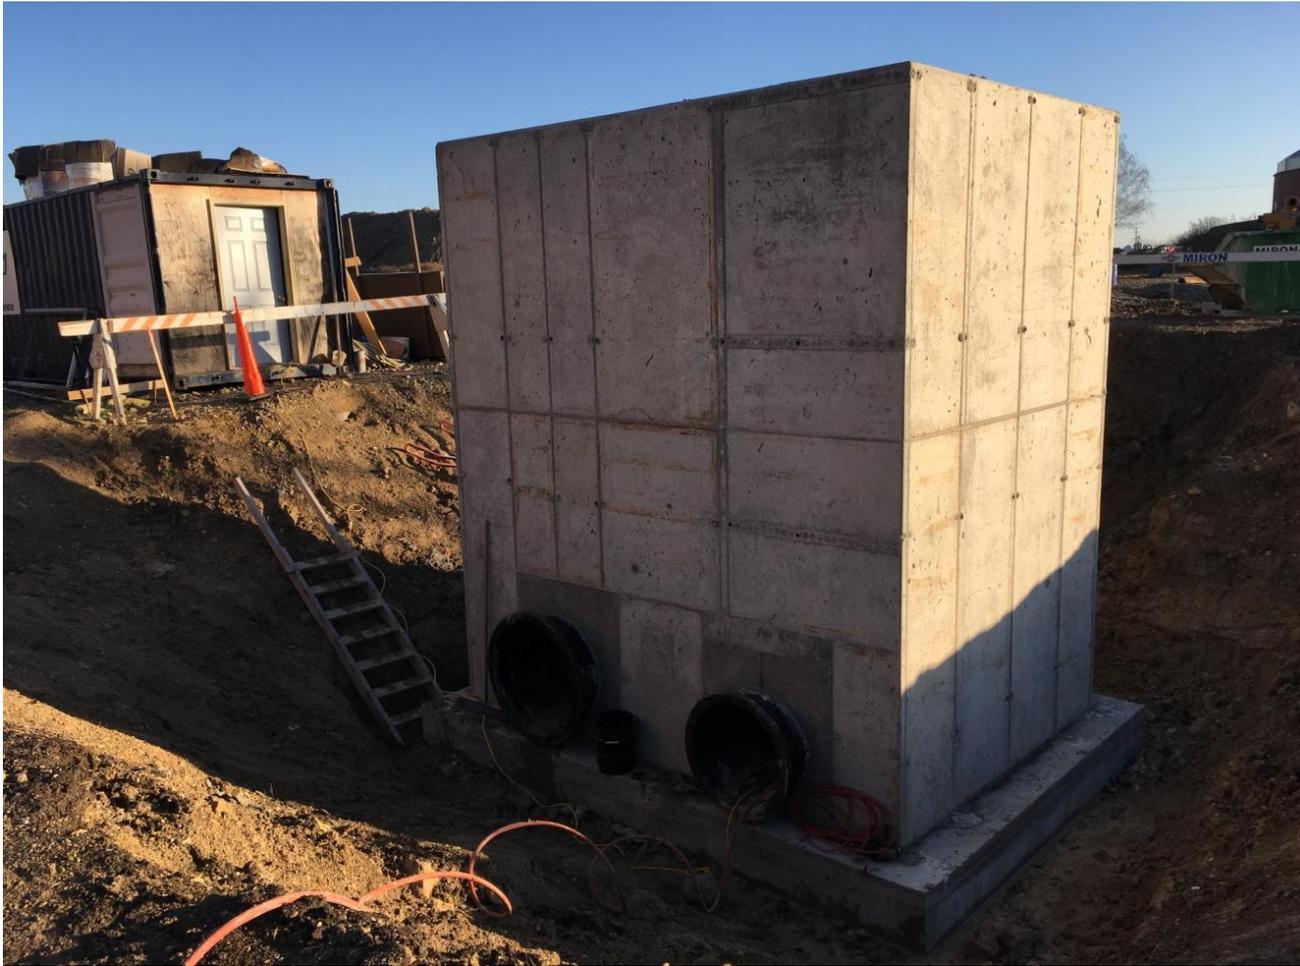
Filter Bypass Splitter – 11/29/16

The larger diameter pipe directs flow to the filter cells under normal conditions while the smaller pipe directs flow downstream of the filters so it can receive disinfection and aeration during high flow events.

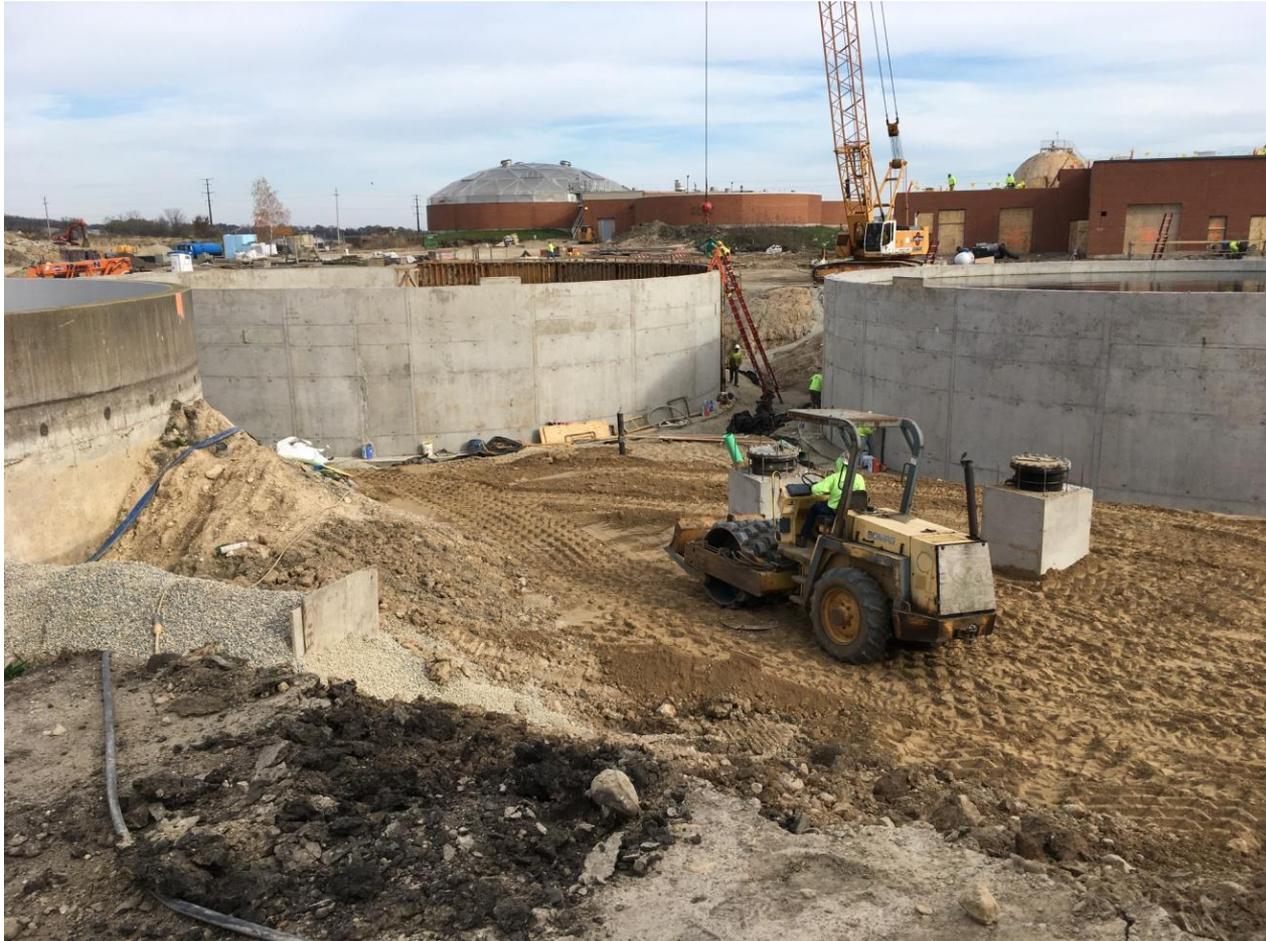
Secondary Clarifiers – 11/14/2016

Contractors backfill in lifts to make sure there will be no issues with settlement at any point in the future. Material type is monitored continuously by the resident engineer.

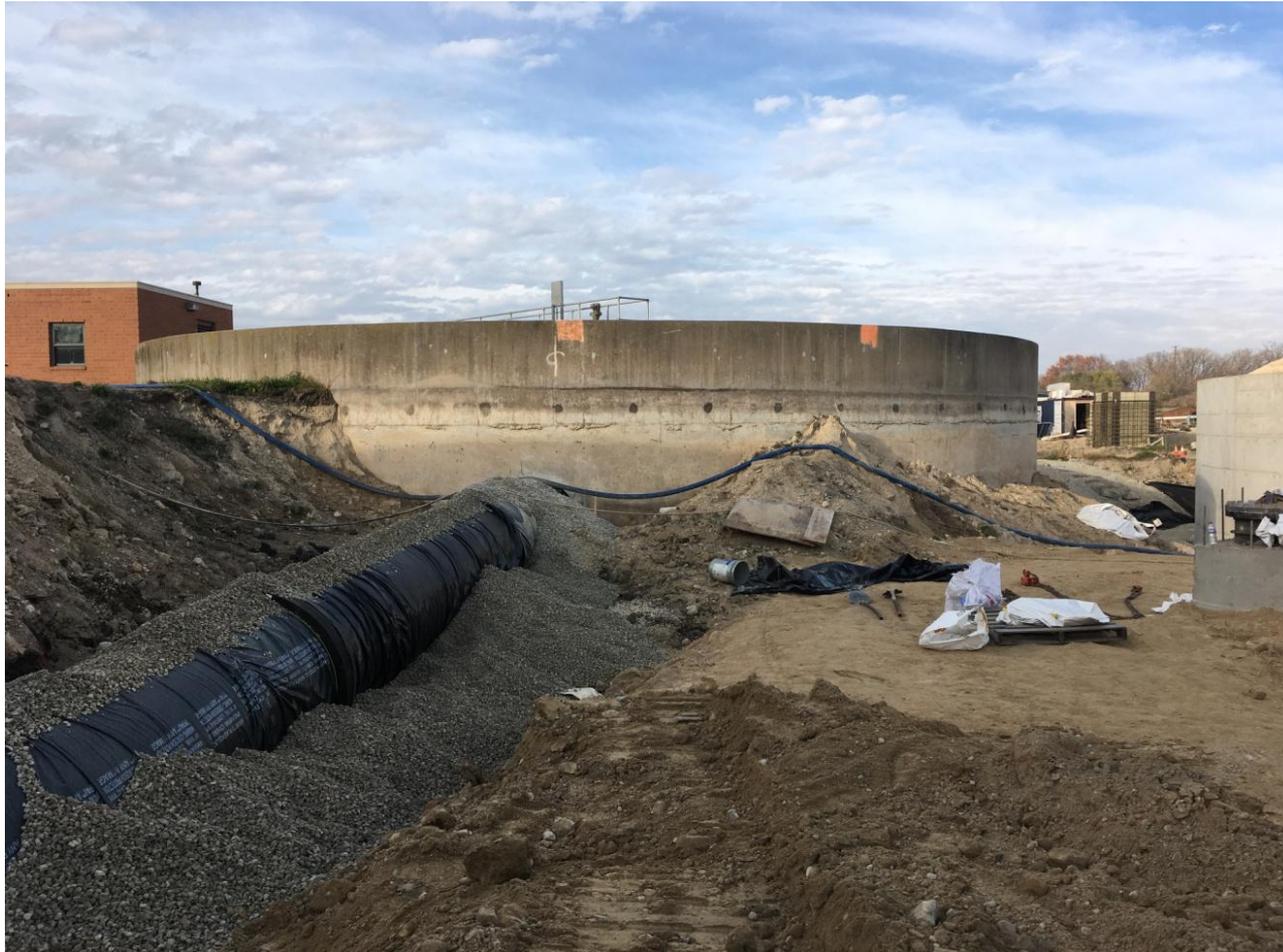
Future Aeration Basin – 11/15/2016

The tank shown is currently used as a secondary clarifier. It will be repurposed as an aeration basin during this upgrade. This design saves additional cost that would have been necessary to construct larger basins.

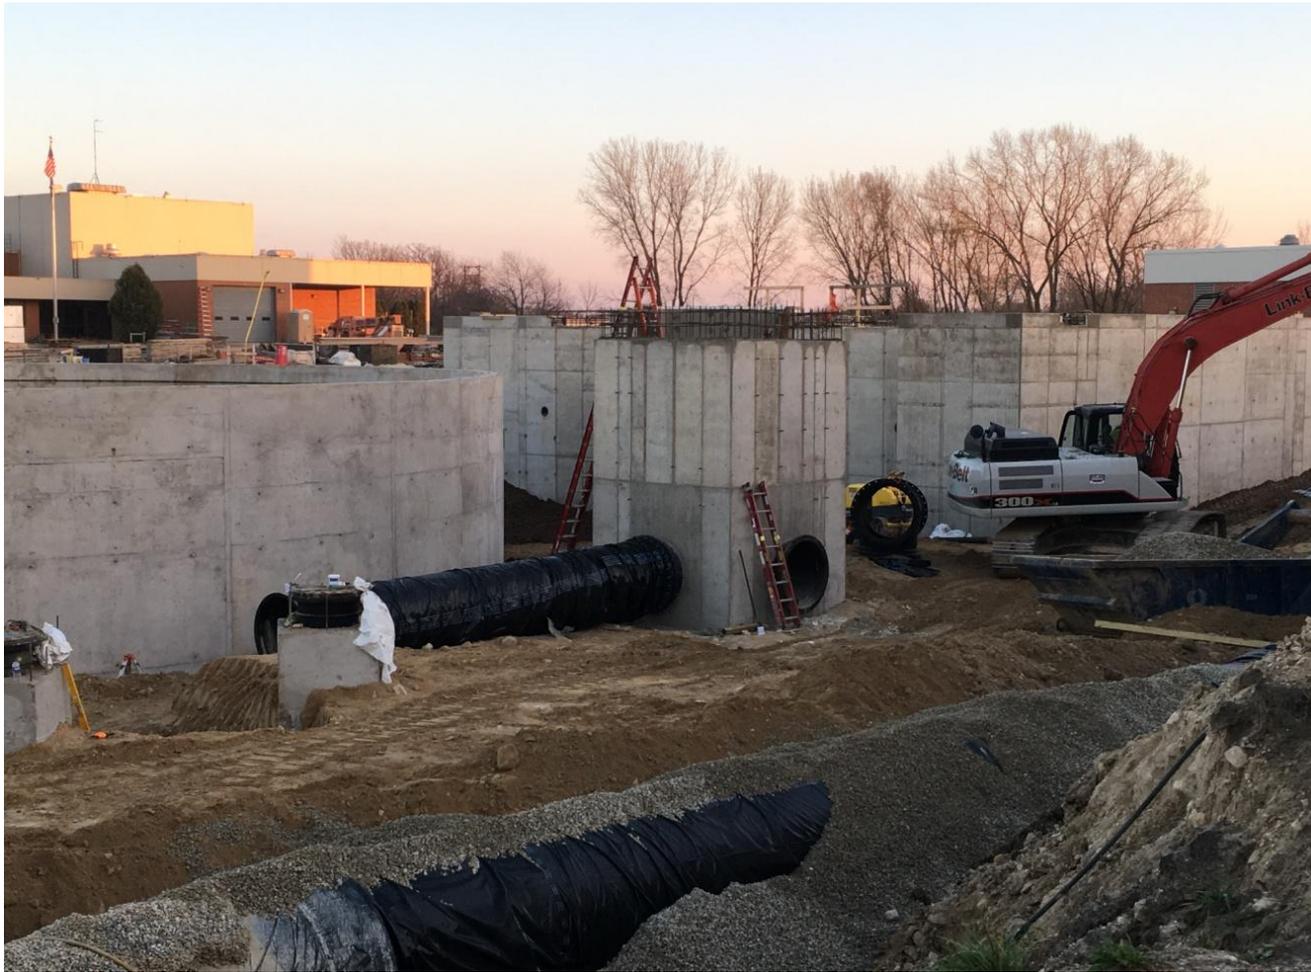
Mixed Liquor Diversion Box – 11/16/2016

The picture above provides an example of the amount and size (42") of pipe that is necessary in order to provide flexibility in the treatment process.

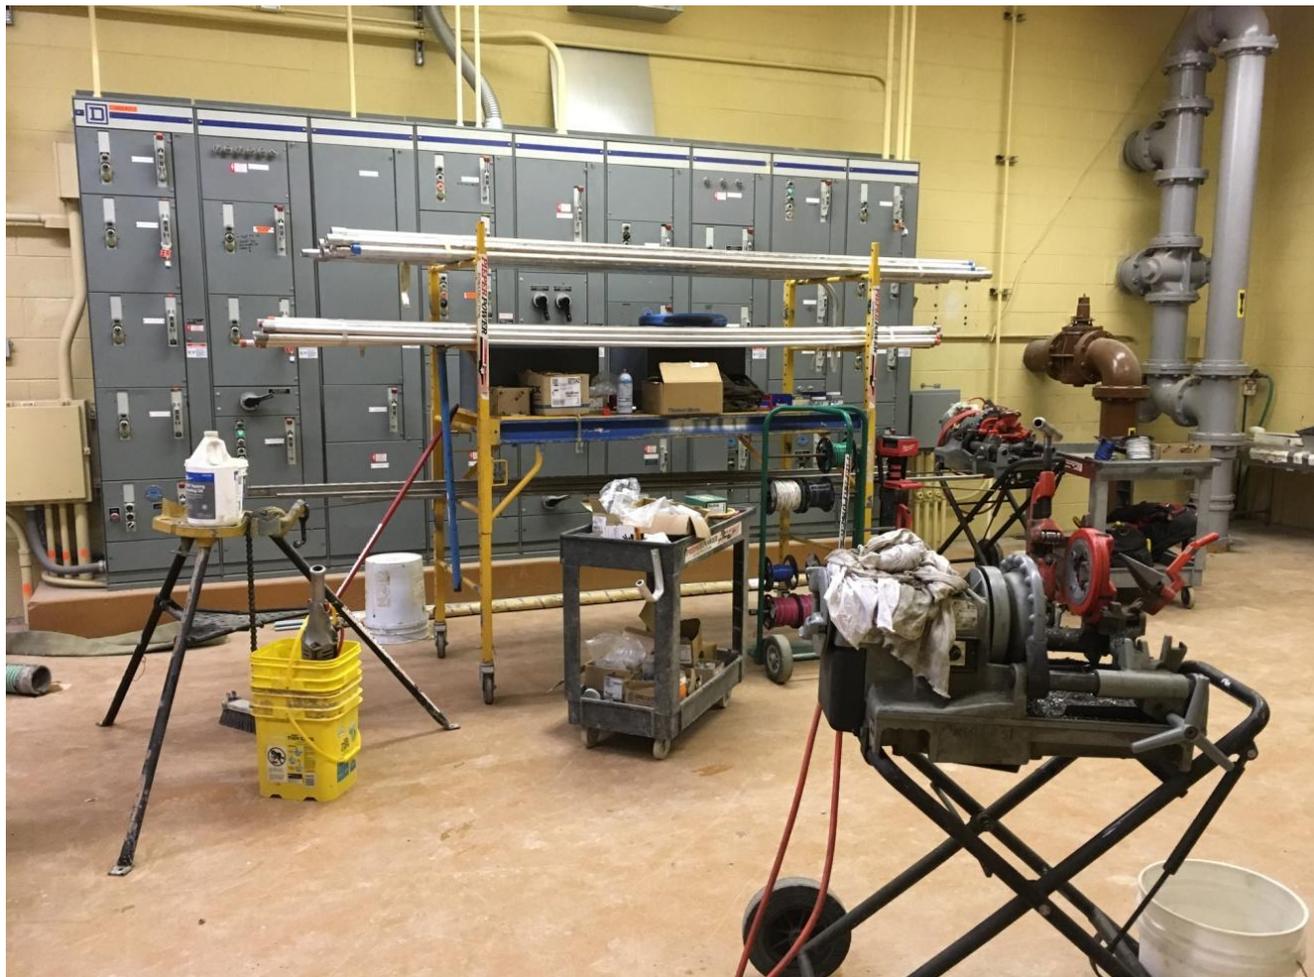
Digester Bldg. – 11/16/2016

The motor control center (MCC) shown will eventually be replaced. Electricians are busy running conduit preparing for the new MCC.

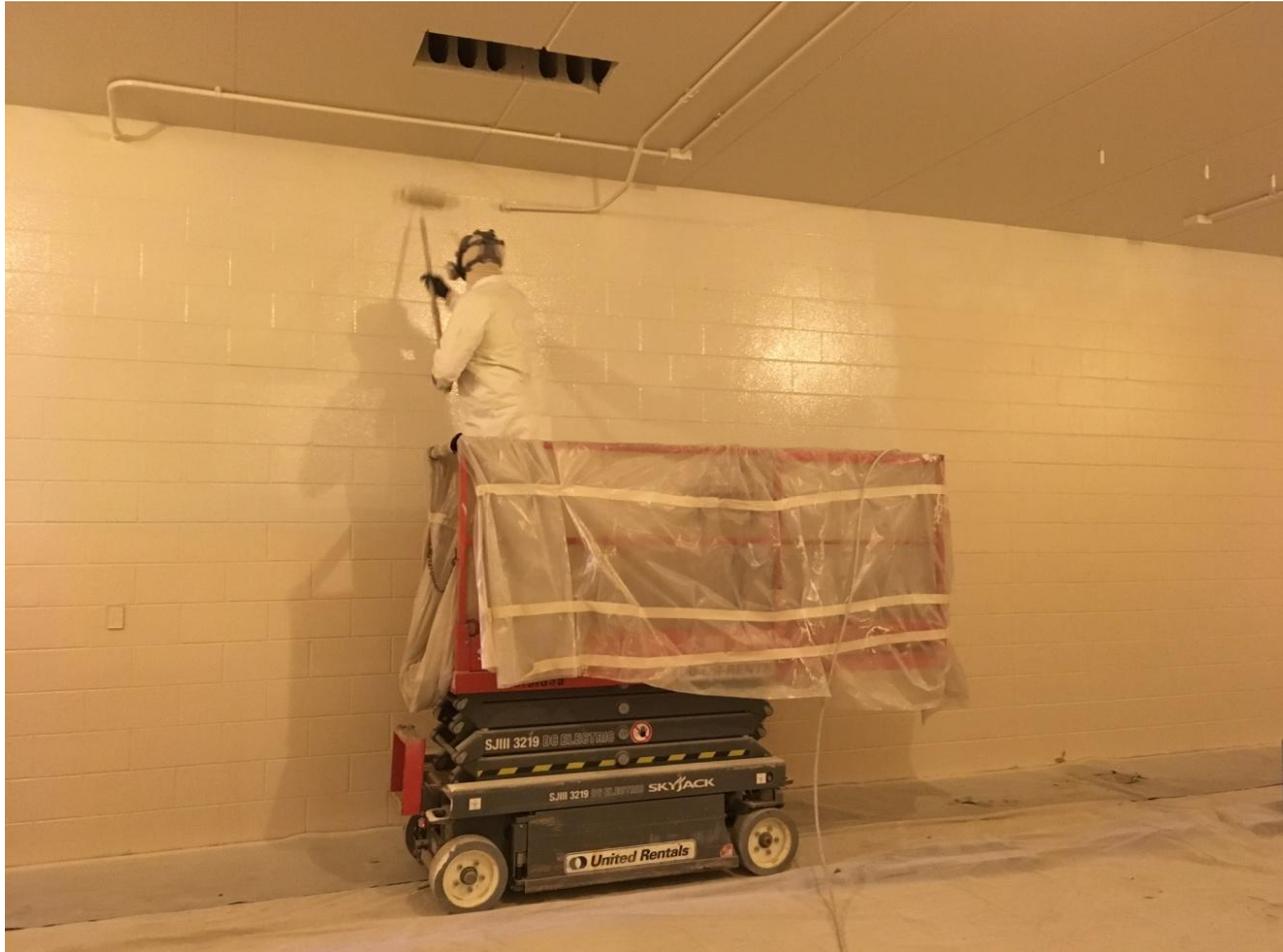
Process Building - Electrical Room, 11/29/2016

Painters have been onsite since 11/15. First the building was heated to properly dry the masonry block. Then, a “block filler” or primer was applied in preparation for two final coats.

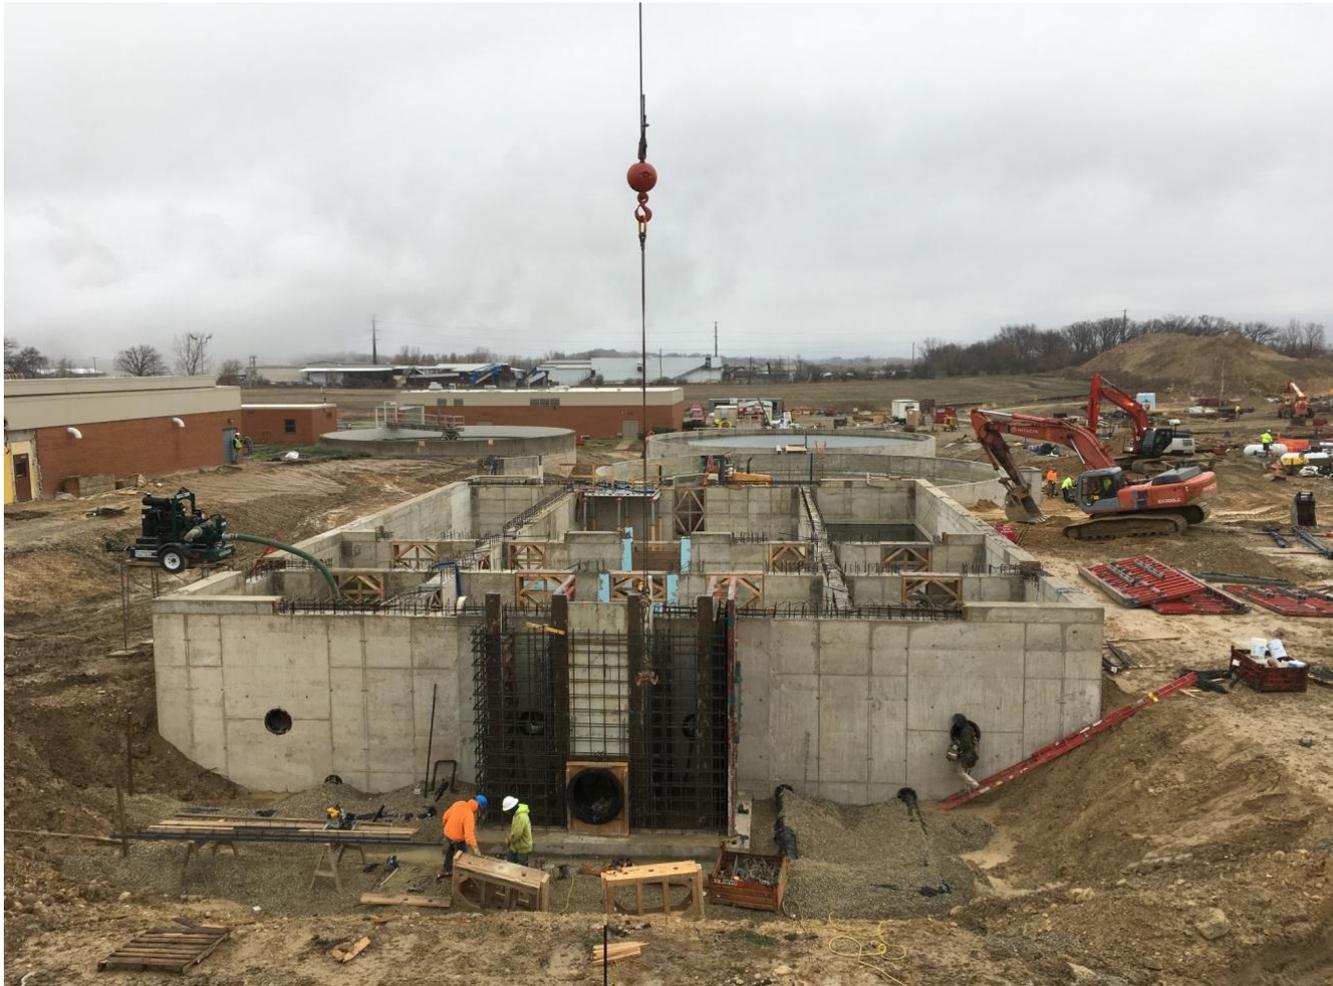
Aeration Basins – 11/30/2016

This overview shows the construction of the primary splitter box as well as the arrangement used to pump water in between tanks for leak testing.

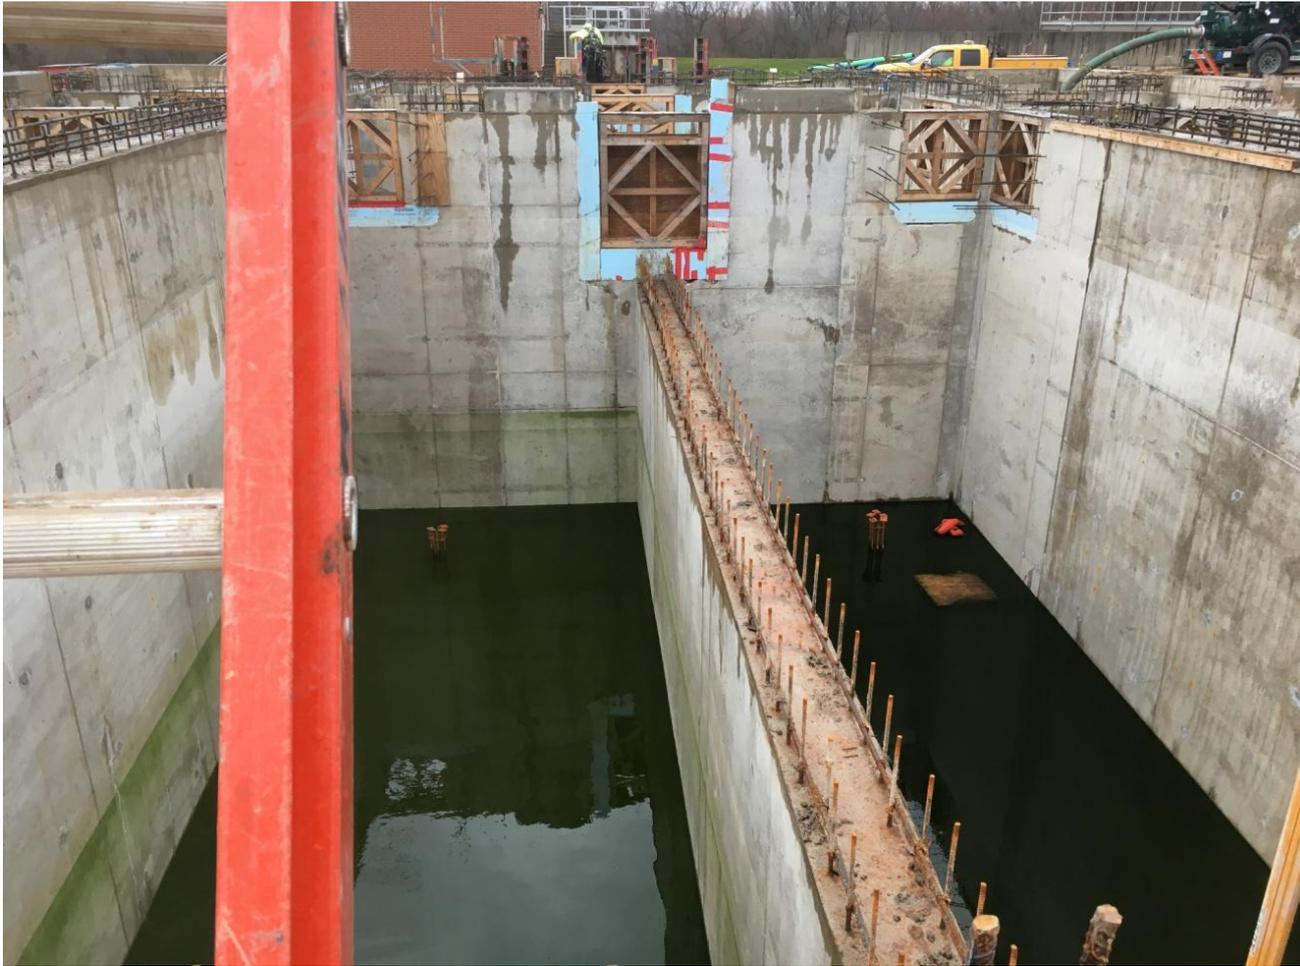
Aeration Basins – 12/1/2016

The majority of the concrete has been poured for the aeration basins. However, rebar shown will tie into flow channels and walkways that are yet to be poured.

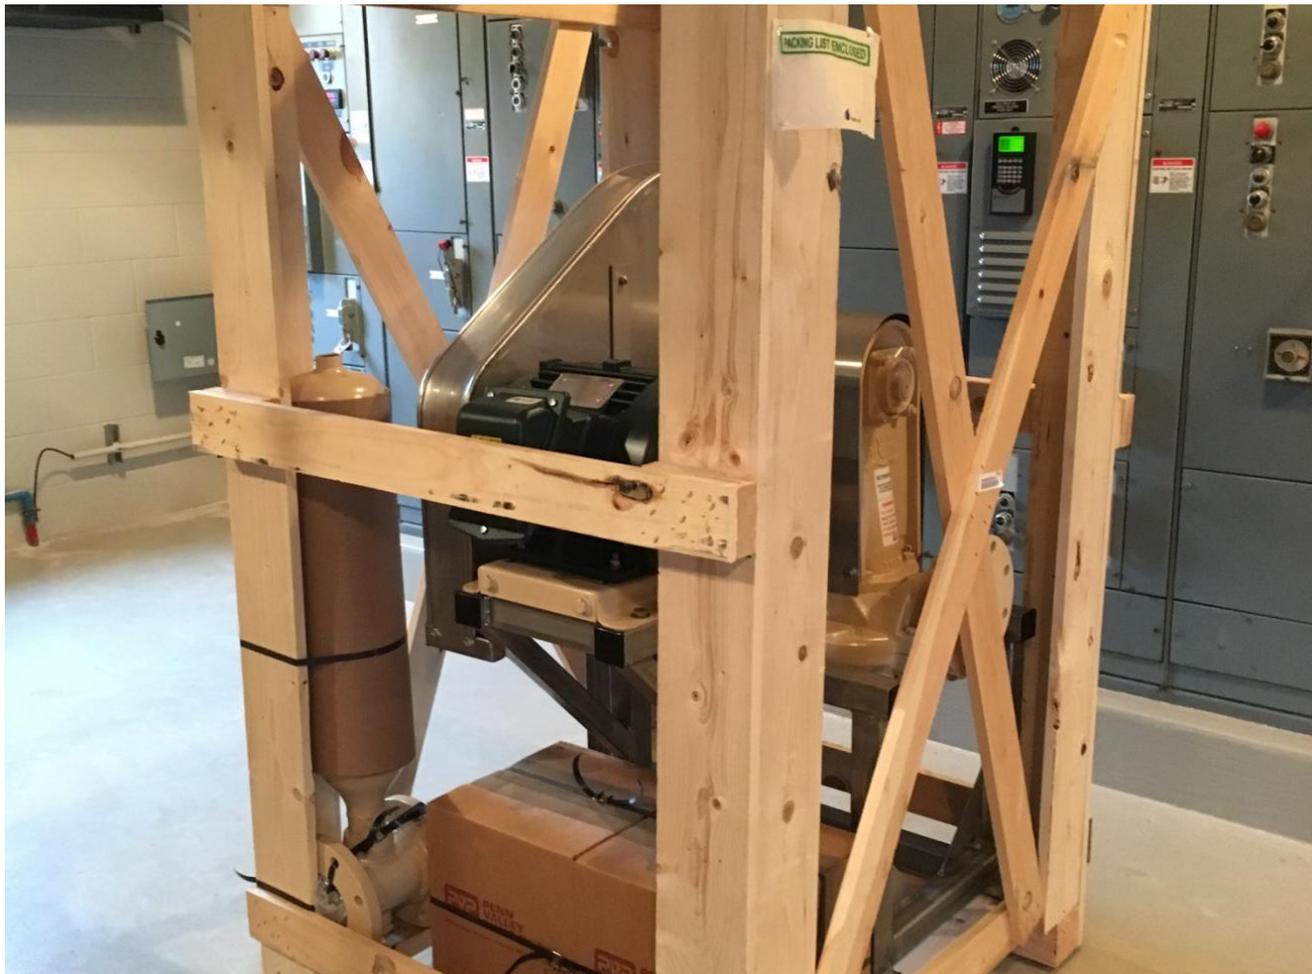
Future Primary Pumps – 11/30/2016

Equipment continues to be delivered as submittals are reviewed and approved. The utility was able to trial this exact style and brand of pump over the last 12 months to verify it would perform as necessary.

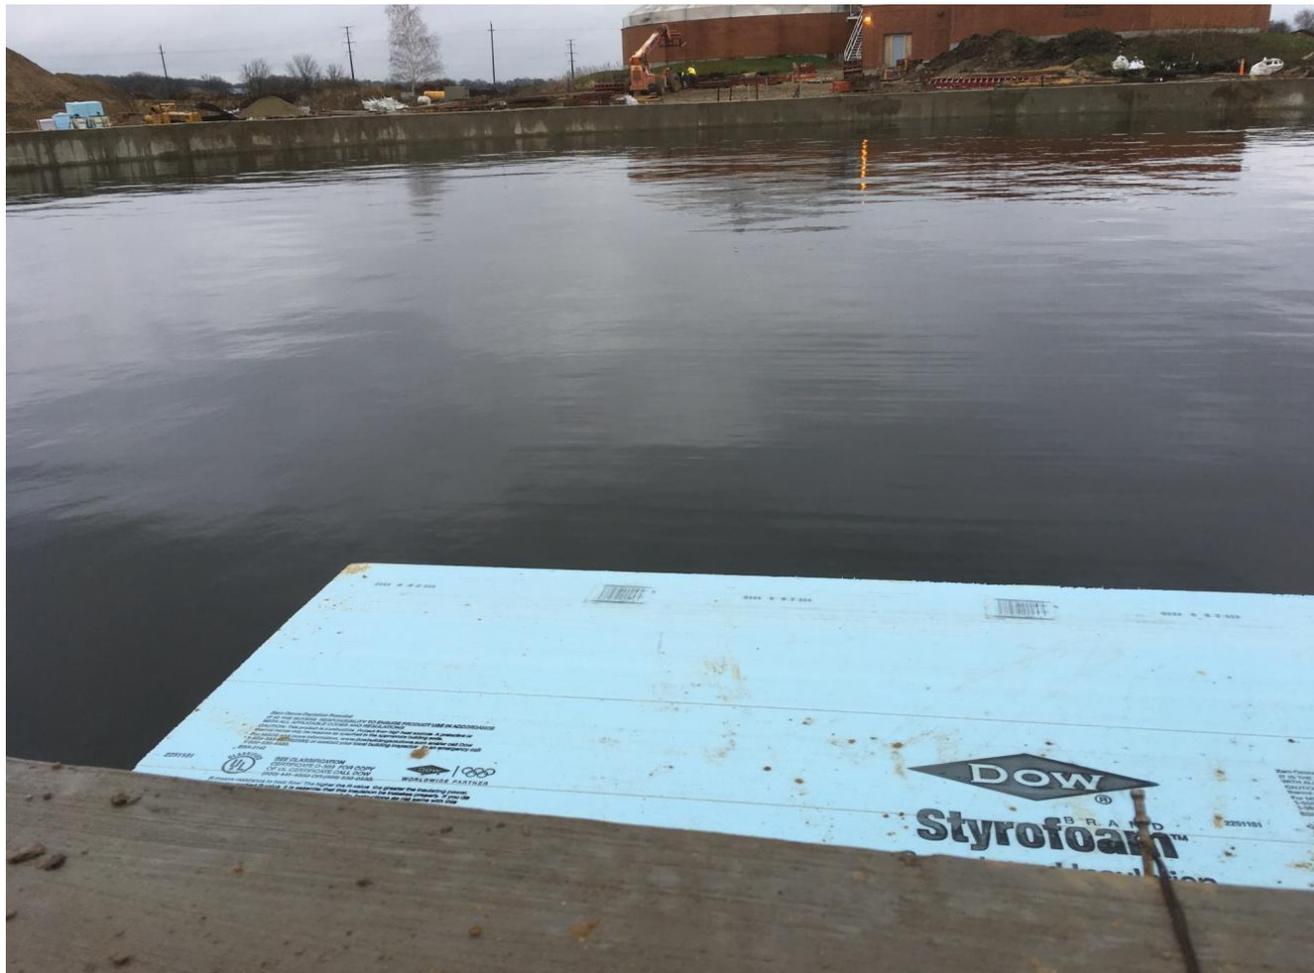
N. Secondary Clarifier – 12/1/2016

Leak testing has been completed in the selector and aeration tanks along with one secondary clarifier tank. Tanks cannot lose more than $1/10^{\text{th}}$ of 1% by volume or have visible exterior leaks.
